Photographs

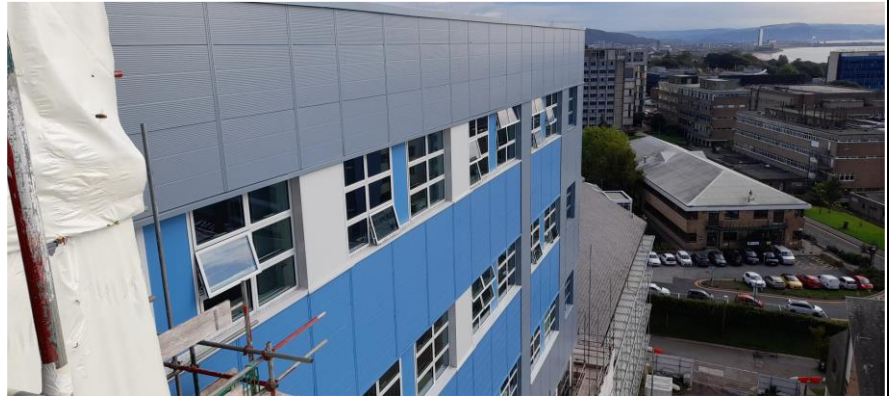
Phase 1 scaffolding removed to expose cladding installed.
