ASBESTOS REINSPECTION REPORT

Client	Swansea Bay NHS
Site	Morrison Nucleus Block Ground Floor, Heol Maes Eglwys, Cwmrhydyceirw, Swansea, SA6 6NL
Date report issued	28th November 2024
Recommended Date for Reinspection	30th October 2025
Survey reference	J1084395
Lead surveyor	Luke Baglow
Assistant surveyor	N/A
UPRN	N/A

No. of Asbestos Risks Identified	
Category A	0
Category B	0
Category C	30
Category D	43
Areas not accessed (Presumed asbestos)	1

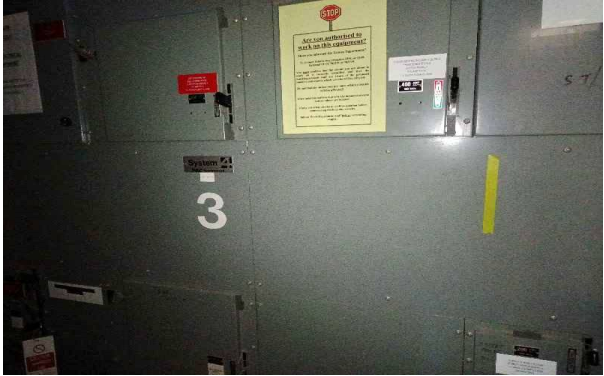
Item / Inspection Ref:	#1	Material Assessment	Product type:	2

Sample Ref:			Condition / Damage:	0		
Survey date:	30/10/2024 - 04/11/2024		Surface Treatment:	2		
Date last inspected:	14/11/2023 12:03:47		Asbestos Type:	1		
Next inspection due:	30th October 2025		Material Score:	5		
Building:	Morrison Nucleus Block Ground Floor	Priority Assessment	Occupant Activity:	1		
Floor level:	Ground Floor		Location:	2		
Room:	A and E 002 (A&E002)		Accessibility:	0		
Position:	Electrics		Extent/amount:	0		Small amounts
Item Description:	Textile Gaskets		Number of Occupants:	1		
Level of Identification:	PRESUMED		Frequency of Use:	3		
Action:	Monitor and manage		Time in Area:	0		
RISK CODE:	C		Maintenance activity:	0		
		Frequency of Maintenance:	0			
		Priority Score:	4			
		Total Score:	9			
Comments:	95091/25				Material Status Change: No Change

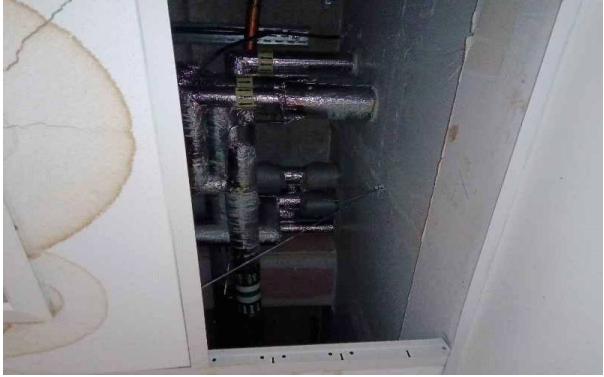
Item / Inspection Ref:	#2	Material Assessment	Product type:	2

Sample Ref:			Condition / Damage:	0		
Survey date:	30/10/2024 - 04/11/2024		Surface Treatment:	1		
Date last inspected:	14/11/2023 12:04:50		Asbestos Type:	1		
Next inspection due:	30th October 2025		Material Score:	4		
Building:	Morrison Nucleus Block Ground Floor	Priority Assessment	Occupant Activity:	1		
Floor level:	Ground Floor		Location:	2		
Room:	A and E 095 (A&E095)		Accessibility:	0		
Position:	Ceiling Void		Extent/amount:	0		Small amounts
Item Description:	Textile Gaskets		Number of Occupants:	1		
Level of Identification:	PRESUMED		Frequency of Use:	3		
Action:	Monitor and manage		Time in Area:	0		
RISK CODE:	D		Maintenance activity:	0		
		Frequency of Maintenance:	0			
		Priority Score:	4			
		Total Score:	8			
Comments:	95091/39				Material Status Change: No Change

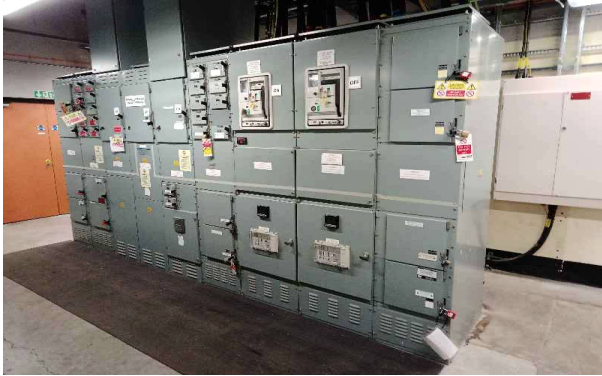
Sample Ref:			Condition / Damage:	0		
Survey date:	30/10/2024 - 04/11/2024		Surface Treatment:	2		
Date last inspected:	14/11/2023 12:05:52		Asbestos Type:	1		
Next inspection due:	30th October 2025		Material Score:	5		
Building:	Morrison Nucleus Block Ground Floor	Priority Assessment	Occupant Activity:	1		
Floor level:	Ground Floor		Location:	2		
Room:	A and E 124 (A&E124)		Accessibility:	0		
Position:	Electrics		Extent/amount:	0		Small amounts
Item Description:	Textile Gaskets		Number of Occupants:	1		
Level of Identification:	PRESUMED		Frequency of Use:	3		
Action:	Monitor and manage		Time in Area:	0		
RISK CODE:	C	Maintenance activity:	0			
Comments:	95091/73	Frequency of Maintenance:	0			
		Priority Score:	4			
			Total Score:	9	Material Status Change:	
					No Change

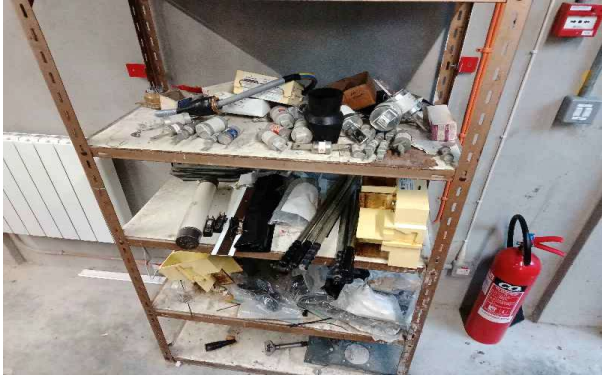
Sample Ref:	674270224 {ZC002067}		Condition / Damage:	0		
Survey date:	30/10/2024 - 04/11/2024		Surface Treatment:	2		
Date last inspected:	14/11/2023 12:06:22		Asbestos Type:	1		
Next inspection due:	30th October 2025		Material Score:	5		
Building:	Morrison Nucleus Block Ground Floor	Priority Assessment	Occupant Activity:	1		
Floor level:	Ground Floor		Location:	2		
Room:	A and E 124 (A&E124)		Accessibility:	0		
Position:	Loose Fuses		Extent/amount:	0		<10m ²

Item Description:	Textile Gaskets		Number of Occupants:	1		
Level of Identification:	SAMPLED		Frequency of Use:	3		
Action:	Monitor and manage		Time in Area:	0		
RISK CODE:	C	Maintenance activity:	0			
Comments:	95091/38. Several fuses noted - small, medium and large. Asbestos identified inside the medium sized fuse.	Frequency of Maintenance:	0			
		Priority Score:	4			
			Total Score:	9	Material Status Change:	
					No Change

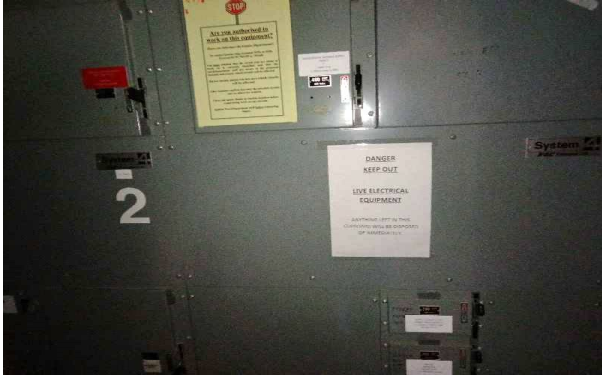
Sample Ref:			Condition / Damage:	0			
Survey date:	30/10/2024 - 04/11/2024		Surface Treatment:	2			
Date last inspected:	14/11/2023 12:08:26		Asbestos Type:	1			
Next inspection due:	30th October 2025		Material Score:	5			
Building:	Morrison Nucleus Block Ground Floor		Priority Assessment	Occupant Activity:		1	
Floor level:	Ground Floor			Location:		2	
Room:	A/B Wards 014 (A/B014)			Accessibility:		0	
Position:	Electrics			Extent/amount:		0	Small amounts
Item Description:	Textile Gaskets			Number of Occupants:		1	
Level of Identification:	PRESUMED	Frequency of Use:		3			
Action:	Monitor and manage	Time in Area:		0			
		Maintenance activity:		0			
		Frequency of Maintenance:		0			
RISK CODE:	C	Priority Score:		4			
		Total Score:	9				
Comments:	95091/22				Material Status Change: No Change

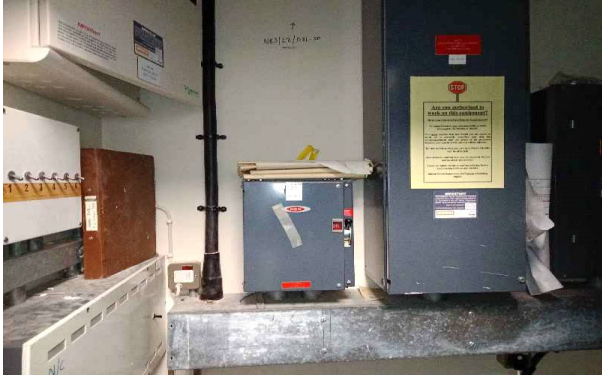
Sample Ref:			Condition / Damage:	0			
Survey date:	30/10/2024 - 04/11/2024		Surface Treatment:	2			
Date last inspected:	14/11/2023 12:09:51		Asbestos Type:	1			
Next inspection due:	30th October 2025		Material Score:	5			
Building:	Morrison Nucleus Block Ground Floor		Priority Assessment	Occupant Activity:		1	
Floor level:	Ground Floor			Location:		2	
Room:	A/B Wards 020 (A/B020)			Accessibility:		0	
Position:	Electrics			Extent/amount:		0	Small amounts
Item Description:	Textile Gaskets			Number of Occupants:		1	
Level of Identification:	PRESUMED	Frequency of Use:		3			
Action:	Monitor and manage	Time in Area:		0			
		Maintenance activity:		0			
		Frequency of Maintenance:		0			
RISK CODE:	C	Priority Score:		4			
		Total Score:	9				
Comments:	95091/34				Material Status Change: No Change

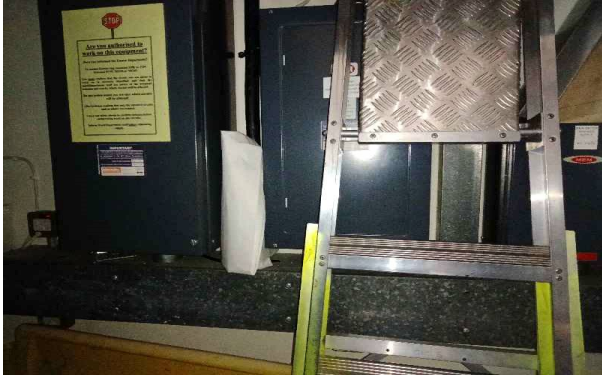
Sample Ref:			Condition / Damage:	0			
Survey date:	30/10/2024 - 04/11/2024		Surface Treatment:	2			
Date last inspected:	14/11/2023 12:12:18		Asbestos Type:	1			
Next inspection due:	30th October 2025		Material Score:	5			
Building:	Morrison Nucleus Block Ground Floor		Priority Assessment	Occupant Activity:		1	
Floor level:	Ground Floor			Location:		2	
Room:	A/B Wards 037 (A/B037)			Accessibility:		0	
Position:	Electrics			Extent/amount:		0	Small amounts
Item Description:	Textile Gaskets			Number of Occupants:		1	
Level of Identification:	PRESUMED	Frequency of Use:		3			
Action:	Monitor and manage	Time in Area:		0			
		Maintenance activity:		0			
		Frequency of Maintenance:		0			
RISK CODE:	C	Priority Score:		4			
		Total Score:	9				
Comments:	95091/36				Material Status Change: No Change

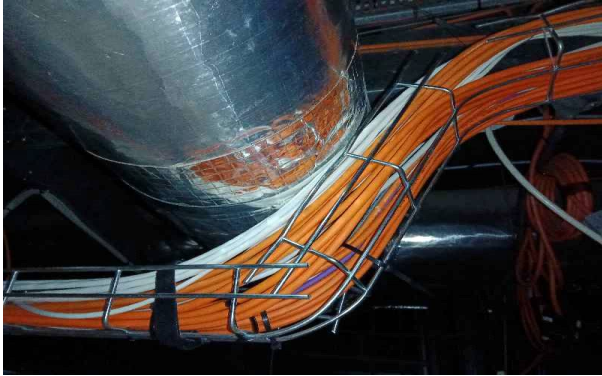
Sample Ref:			Condition / Damage:	0			
Survey date:	30/10/2024 - 04/11/2024		Surface Treatment:	1			
Date last inspected:	14/11/2023 12:12:57		Asbestos Type:	1			
Next inspection due:	30th October 2025		Material Score:	4			
Building:	Morrison Nucleus Block Ground Floor		Priority Assessment	Occupant Activity:		1	
Floor level:	Ground Floor			Location:		2	
Room:	A/B Wards 041 (A/B041)			Accessibility:		0	
Position:	Ceiling Void			Extent/amount:		0	Small amounts
Item Description:	Textile Gaskets			Number of Occupants:		1	
Level of Identification:	PRESUMED	Frequency of Use:		3			
Action:	Monitor and manage	Time in Area:		0			
		Maintenance activity:		0			
		Frequency of Maintenance:		0			
RISK CODE:	D	Priority Score:		4			
		Total Score:	8				
Comments:	95091/35				Material Status Change: No Change

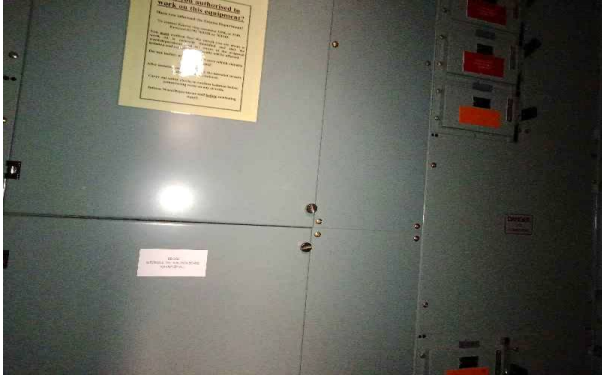
Sample Ref:			Condition / Damage:	0			
Survey date:	30/10/2024 - 04/11/2024		Surface Treatment:	2			
Date last inspected:	14/11/2023 12:14:48		Asbestos Type:	1			
Next inspection due:	30th October 2025		Material Score:	5			
Building:	Morrison Nucleus Block Ground Floor		Priority Assessment	Occupant Activity:		1	
Floor level:	Ground Floor			Location:		2	
Room:	Anglesey and Cardigan Wards 003 (A&C003)			Accessibility:		0	
Position:	Electrics			Extent/amount:		0	Small amounts
Item Description:	Textile Gaskets			Number of Occupants:		1	
Level of Identification:	PRESUMED	Frequency of Use:		3			
Action:	Monitor and manage	Time in Area:		0			
		Maintenance activity:		0			
		Frequency of Maintenance:		0			
RISK CODE:	C	Priority Score:		4			
		Total Score:	9				
Comments:	95091/58				Material Status Change: No Change

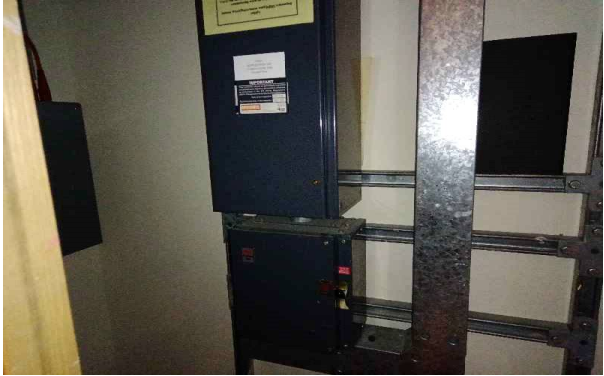
Sample Ref:			Condition / Damage:	0			
Survey date:	30/10/2024 - 04/11/2024		Surface Treatment:	2			
Date last inspected:	14/11/2023 12:15:23		Asbestos Type:	1			
Next inspection due:	30th October 2025		Material Score:	5			
Building:	Morrison Nucleus Block Ground Floor		Priority Assessment	Occupant Activity:		1	
Floor level:	Ground Floor			Location:		2	
Room:	Anglesey and Cardigan Wards 012 (A&C012)			Accessibility:		0	
Position:	Electrics			Extent/amount:		0	Small amounts
Item Description:	Textile Gaskets			Number of Occupants:		1	
Level of Identification:	PRESUMED	Frequency of Use:		3			
Action:	Monitor and manage	Time in Area:		0			
		Maintenance activity:		0			
		Frequency of Maintenance:		0			
RISK CODE:	C	Priority Score:		4			
		Total Score:	9				
Comments:	95091/92				Material Status Change: No Change

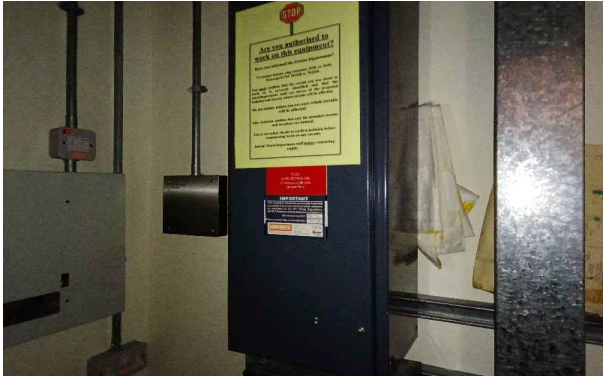
Sample Ref:			Condition / Damage:	0			
Survey date:	30/10/2024 - 04/11/2024		Surface Treatment:	2			
Date last inspected:	14/11/2023 12:15:55		Asbestos Type:	1			
Next inspection due:	30th October 2025		Material Score:	5			
Building:	Morrison Nucleus Block Ground Floor		Priority Assessment	Occupant Activity:		1	
Floor level:	Ground Floor			Location:		2	
Room:	Anglesey and Cardigan Wards 013 (A&C013)			Accessibility:		0	
Position:	Electrics			Extent/amount:		0	Small amounts
Item Description:	Textile Gaskets			Number of Occupants:		1	
Level of Identification:	PRESUMED	Frequency of Use:		3			
Action:	Monitor and manage	Time in Area:		0			
		Maintenance activity:		0			
		Frequency of Maintenance:		0			
RISK CODE:	C	Priority Score:		4			
		Total Score:	9				
Comments:	95091/93				Material Status Change: No Change

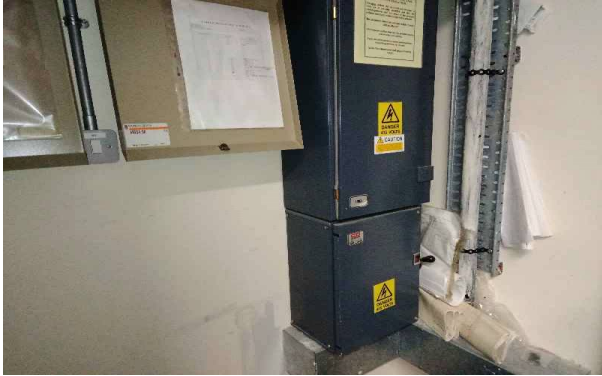
Sample Ref:			Condition / Damage:	0			
Survey date:	30/10/2024 - 04/11/2024		Surface Treatment:	2			
Date last inspected:	14/11/2023 12:16:38		Asbestos Type:	1			
Next inspection due:	30th October 2025		Material Score:	5			
Building:	Morrison Nucleus Block Ground Floor		Priority Assessment	Occupant Activity:		1	
Floor level:	Ground Floor			Location:		2	
Room:	C Evans and Danio 051 (C&D051)			Accessibility:		0	
Position:	Electrics			Extent/amount:		0	Small amounts
Item Description:	Textile Gaskets			Number of Occupants:		1	
Level of Identification:	PRESUMED	Frequency of Use:		3			
Action:	Monitor and manage	Time in Area:		0			
		Maintenance activity:		0			
		Frequency of Maintenance:		0			
RISK CODE:	C	Priority Score:		4			
		Total Score:	9				
Comments:	95091/103				Material Status Change: No Change

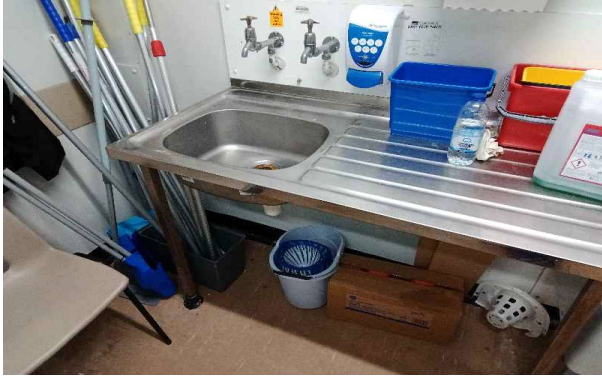
Sample Ref:	338010224 (ZC002068)		Condition / Damage:	0			
Survey date:	30/10/2024 - 04/11/2024		Surface Treatment:	0			
Date last inspected:	14/11/2023 12:17:21		Asbestos Type:	1			
Next inspection due:	30th October 2025		Material Score:	2			
Building:	Morrison Nucleus Block Ground Floor		Priority Assessment	Occupant Activity:		1	
Floor level:	Ground Floor			Location:		2	
Room:	C/D Wards 006 (C/D006)			Accessibility:		0	
Position:	To Sink			Extent/amount:		0	Small amounts
Item Description:	Sink Pad			Number of Occupants:		1	
Level of Identification:	SAMPLED	Frequency of Use:		3			
Action:	Monitor and manage	Time in Area:		0			
		Maintenance activity:		0			
		Frequency of Maintenance:		0			
RISK CODE:	D	Priority Score:		4			
		Total Score:	6				
Comments:	95091/102				Material Status Change: No Change

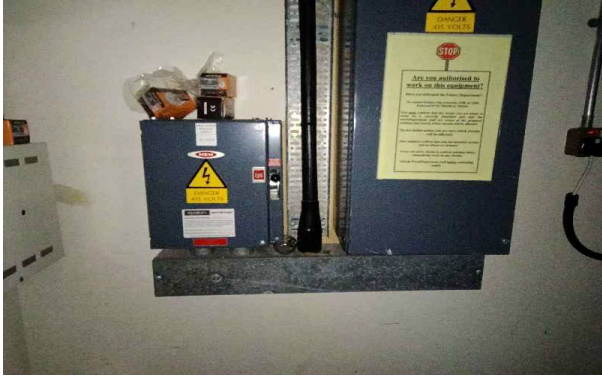
Sample Ref:			Condition / Damage:	0			
Survey date:	30/10/2024 - 04/11/2024		Surface Treatment:	2			
Date last inspected:	14/11/2023 12:18:36		Asbestos Type:	1			
Next inspection due:	30th October 2025		Material Score:	5			
Building:	Morrison Nucleus Block Ground Floor		Priority Assessment	Occupant Activity:		1	
Floor level:	Ground Floor			Location:		2	
Room:	C/D Wards 009 (C/D009)			Accessibility:		0	
Position:	Electrics			Extent/amount:		0	Small amounts
Item Description:	Textile Gaskets			Number of Occupants:		1	
Level of Identification:	PRESUMED	Frequency of Use:		3			
Action:	Monitor and manage	Time in Area:		0			
		Maintenance activity:		0			
		Frequency of Maintenance:		0			
RISK CODE:	C	Priority Score:		4			
		Total Score:	9				
Comments:	95091/101				Material Status Change: No Change

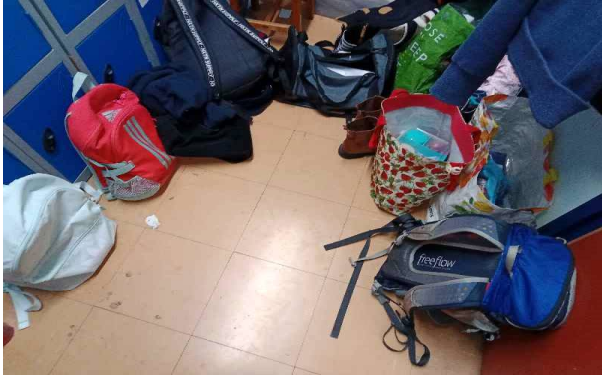
Sample Ref:			Condition / Damage:	0			
Survey date:	30/10/2024 - 04/11/2024		Surface Treatment:	0			
Date last inspected:	14/11/2023 12:25:27		Asbestos Type:	1			
Next inspection due:	30th October 2025		Material Score:	2			
Building:	Morrison Nucleus Block Ground Floor		Priority Assessment	Occupant Activity:		1	
Floor level:	Ground Floor			Location:		2	
Room:	F Ward and SDMU 007 (F&SDMU007)			Accessibility:		1	
Position:	Floor			Extent/amount:		1	<10
Item Description:	Floor Tiles and Adhesive			Number of Occupants:		1	
Level of Identification:	PRESUMED	Frequency of Use:		3			
Action:	Monitor and manage	Time in Area:		0			
		Maintenance activity:		0			
		Frequency of Maintenance:		0			
RISK CODE:	D	Priority Score:		5			
		Total Score:	7				
Comments:	95091/89. Present in adhesive.				Material Status Change: No Change

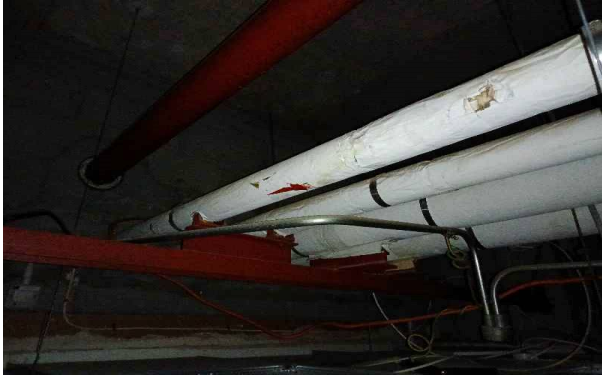
Sample Ref:	996490224 {ZC002072}		Condition / Damage:	1		
Survey date:	30/10/2024 - 04/11/2024		Surface Treatment:	1		
Date last inspected:	14/11/2023 12:37:17		Asbestos Type:	1		
Next inspection due:	30th October 2025		Material Score:	5		
Building:	Morrison Nucleus Block Ground Floor	Priority Assessment	Occupant Activity:	1		
Floor level:	Ground Floor		Location:	2		
Room:	Hotel Services 027 (HSRV027)		Accessibility:	0		
Position:	Ceiling Void		Extent/amount:	0		Small amounts
Item Description:	Textile Gaskets		Number of Occupants:	1		
Level of Identification:	SAMPLED		Frequency of Use:	3		
Action:	Monitor and manage		Time in Area:	0		
RISK CODE:	C	Maintenance activity:	0			
		Frequency of Maintenance:	0			
		Priority Score:	4			
		Total Score:	9			
Comments:	95091/44				Material Status Change:	
					No Change

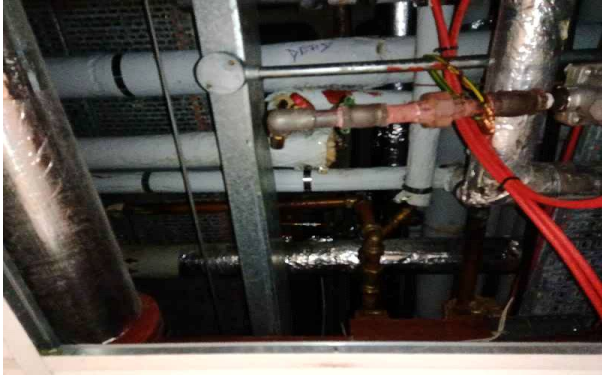
Sample Ref:	676060224 {ZC002073}		Condition / Damage:	1		
Survey date:	30/10/2024 - 04/11/2024		Surface Treatment:	1		
Date last inspected:	14/11/2023 12:38:20		Asbestos Type:	1		
Next inspection due:	30th October 2025		Material Score:	5		
Building:	Morrison Nucleus Block Ground Floor	Priority Assessment	Occupant Activity:	1		
Floor level:	Ground Floor		Location:	2		
Room:	Hotel Services 028 (HSRV028)		Accessibility:	0		
Position:	Ceiling Void		Extent/amount:	0		Small amounts
Item Description:	Textile Gaskets		Number of Occupants:	1		
Level of Identification:	SAMPLED		Frequency of Use:	3		
Action:	Monitor and manage		Time in Area:	0		
RISK CODE:	C	Maintenance activity:	0			
		Frequency of Maintenance:	0			
		Priority Score:	4			
		Total Score:	9			
Comments:	95091/46				Material Status Change:	
					No Change

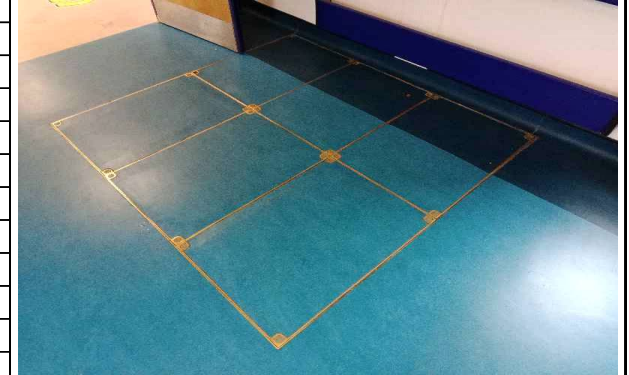
Item / Inspection Ref:	#41	Material Assessment	Product type:		
Sample Ref:			Condition / Damage:		
Survey date:	30/10/2024 - 04/11/2024		Surface Treatment:		
Date last inspected:	14/11/2023 12:43:43		Asbestos Type:		
Next inspection due:	30th October 2025		Material Score:		
Building:	Morrison Nucleus Block Ground Floor		Priority Assessment	Occupant Activity:	
Floor level:	Ground Floor			Location:	
Room:	Main Street 01 (MS01)			Accessibility:	
Position:	Floor			Extent/amount:	
Item Description:	Floor Duct			Number of Occupants:	
Level of Identification:	INACCESSIBLE (PRESUMED)	Frequency of Use:			
Action:		Time in Area:			
		Maintenance activity:			
		Frequency of Maintenance:			
RISK CODE:	No Access	Priority Score:			
		Total Score:			
Comments:		Material Status Change:			
		No Change

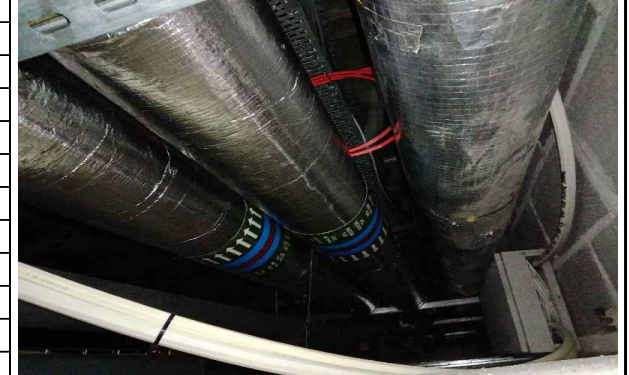
Item / Inspection Ref:	#42	Material Assessment	Product type:	2	
Sample Ref:			Condition / Damage:	0	
Survey date:	30/10/2024 - 04/11/2024		Surface Treatment:	1	
Date last inspected:	14/11/2023 12:44:17		Asbestos Type:	1	
Next inspection due:	30th October 2025		Material Score:	4	
Building:	Morrison Nucleus Block Ground Floor		Priority Assessment	Occupant Activity:	1
Floor level:	Ground Floor			Location:	2
Room:	Main Street 02 (MS02)			Accessibility:	0
Position:	Ceiling Void			Extent/amount:	0 Small amounts
Item Description:	Textile Gaskets			Number of Occupants:	1
Level of Identification:	PRESUMED	Frequency of Use:		3	
Action:	Monitor and manage	Time in Area:		0	
		Maintenance activity:		0	
		Frequency of Maintenance:		0	
RISK CODE:	D	Priority Score:		4	
		Total Score:	8		
Comments:	95091/03	Material Status Change:			
		No Change

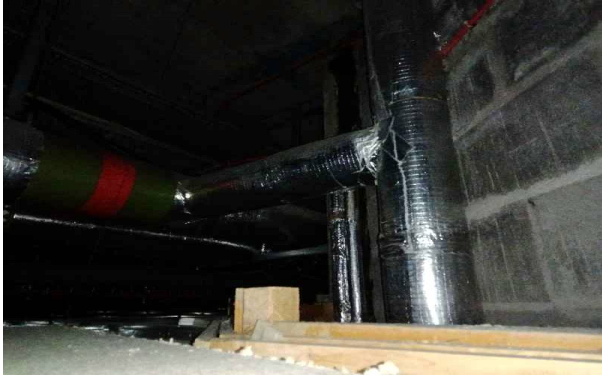
Item / Inspection Ref:	#43	Material Assessment	Product type:	2

Sample Ref:			Condition / Damage:	0			
Survey date:	30/10/2024 - 04/11/2024		Surface Treatment:	1			
Date last inspected:	14/11/2023 12:45:02		Asbestos Type:	1			
Next inspection due:	30th October 2025		Material Score:	4			
Building:	Morrison Nucleus Block Ground Floor		Priority Assessment	Occupant Activity:		1	
Floor level:	Ground Floor			Location:		2	
Room:	Main Street 03 (MS03)			Accessibility:		0	
Position:	Ceiling Void			Extent/amount:		0	Small amounts
Item Description:	Textile Gaskets			Number of Occupants:		1	
Level of Identification:	PRESUMED	Frequency of Use:		3			
Action:	Monitor and manage	Time in Area:		0			
		Maintenance activity:		0			
		Frequency of Maintenance:		0			
RISK CODE:	D	Priority Score:		4			
		Total Score:	8				
Comments:	95091/18				Material Status Change: No Change

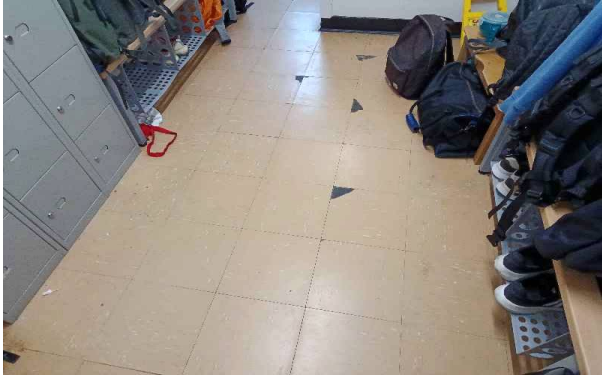
Sample Ref:			Condition / Damage:	1			
Survey date:	30/10/2024 - 04/11/2024		Surface Treatment:	0			
Date last inspected:	14/11/2023 12:51:38		Asbestos Type:	1			
Next inspection due:	30th October 2025		Material Score:	3			
Building:	Morrison Nucleus Block Ground Floor		Priority Assessment	Occupant Activity:		1	
Floor level:	Ground Floor			Location:		2	
Room:	Rehab 011 (R011)			Accessibility:		1	
Position:	Floor			Extent/amount:		2	10-50m ²
Item Description:	Floor Tiles and Adhesive			Number of Occupants:		1	
Level of Identification:	PRESUMED	Frequency of Use:		3			
Action:	Monitor and manage	Time in Area:		0			
		Maintenance activity:		0			
		Frequency of Maintenance:		0			
RISK CODE:	D	Priority Score:		5			
		Total Score:	8				
Comments:	95091/81				Material Status Change: No Change

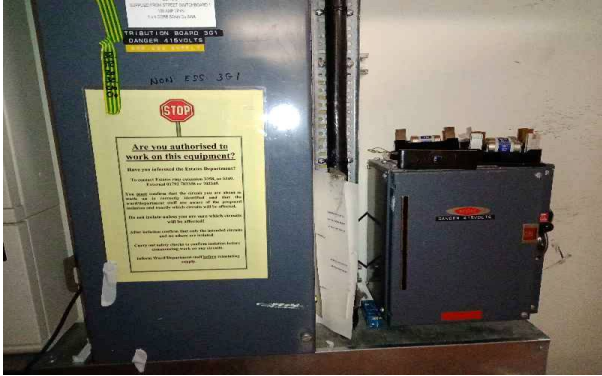
Sample Ref:			Condition / Damage:	0		
Survey date:	30/10/2024 - 04/11/2024	Surface Treatment:	2			
Date last inspected:	14/11/2023 12:53:11	Asbestos Type:	1			
Next inspection due:	30th October 2025	Material Score:	5			
Building:	Morrison Nucleus Block Ground Floor	Priority Assessment	Occupant Activity:	1		
Floor level:	Ground Floor		Location:	2		
Room:	Rehab 019 (R019)		Accessibility:	0		
Position:	Electrics		Extent/amount:	0		Small amounts
Item Description:	Textile Gaskets		Number of Occupants:	1		
Level of Identification:	PRESUMED		Frequency of Use:	3		
Action:	Monitor and manage		Time in Area:	0		
			Maintenance activity:	0		
RISK CODE:	C	Frequency of Maintenance:	0			
		Priority Score:	4			
		Total Score:	9			
Comments:	95091/80 Loose fuses present.				Material Status Change:	
					No Change

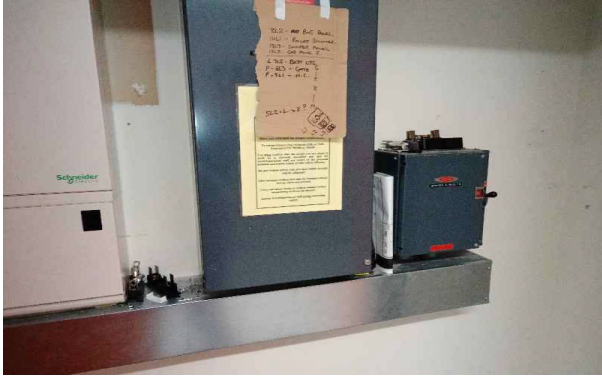
Sample Ref:			Condition / Damage:	0		
Survey date:	30/10/2024 - 04/11/2024	Surface Treatment:	2			
Date last inspected:	14/11/2023 12:53:44	Asbestos Type:	1			
Next inspection due:	30th October 2025	Material Score:	5			
Building:	Morrison Nucleus Block Ground Floor	Priority Assessment	Occupant Activity:	1		
Floor level:	Ground Floor		Location:	2		
Room:	Rehab 027 (R027)		Accessibility:	0		
Position:	Electrics		Extent/amount:	0		Small amounts
Item Description:	Textile Gaskets		Number of Occupants:	1		
Level of Identification:	PRESUMED		Frequency of Use:	3		
Action:	Monitor and manage		Time in Area:	0		
			Maintenance activity:	0		
RISK CODE:	C	Frequency of Maintenance:	0			
		Priority Score:	4			
		Total Score:	9			
Comments:	95091/78 Loose fuses present.				Material Status Change:	
					Updated

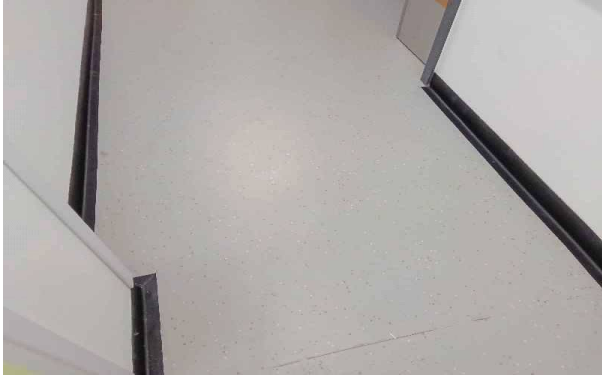
Sample Ref:	739470221 (ZC002075)		Condition / Damage:	0			
Survey date:	30/10/2024 - 04/11/2024		Surface Treatment:	0			
Date last inspected:	14/11/2023 12:57:10		Asbestos Type:	1			
Next inspection due:	30th October 2025		Material Score:	2			
Building:	Morrison Nucleus Block Ground Floor		Priority Assessment	Occupant Activity:		1	
Floor level:	Ground Floor			Location:		2	
Room:	Rehab 055 (R055)			Accessibility:		1	
Position:	Floor			Extent/amount:		2	10-50m ²
