ASBESTOS REINSPECTION REPORT

Client	Swansea Bay NHS
Site	Morrison Nucleus Block Ground Floor, Heol Maes Eglwys, Cwmrhydyceirw, Swansea, SA6 6NL
Date report issued	28th November 2024
Recommended Date for Reinspection	30th October 2025
Survey reference	J1084395
Lead surveyor	Luke Baglow
Assistant surveyor	N/A
UPRN	N/A

No. of Asbestos Risks Identified	
Category A	0
Category B	0
Category C	30
Category D	43
Areas not accessed (Presumed asbestos)	1

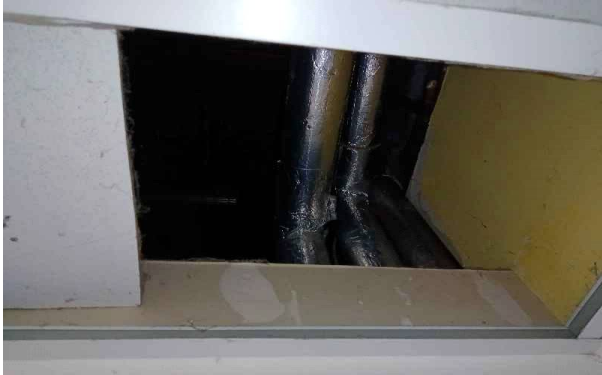
Item / Inspection Ref:	#9	Material Assessment	Product type:	2

Sample Ref:			Condition / Damage:	0			
Survey date:	30/10/2024 - 04/11/2024		Surface Treatment:	1			
Date last inspected:	14/11/2023 12:12:57		Asbestos Type:	1			
Next inspection due:	30th October 2025		Material Score:	4			
Building:	Morrison Nucleus Block Ground Floor		Priority Assessment	Occupant Activity:		1	
Floor level:	Ground Floor			Location:		2	
Room:	A/B Wards 041 (A/B041)			Accessibility:		0	
Position:	Ceiling Void			Extent/amount:		0	Small amounts
Item Description:	Textile Gaskets			Number of Occupants:		1	
Level of Identification:	PRESUMED	Frequency of Use:		3			
Action:	Monitor and manage	Time in Area:		0			
		Maintenance activity:		0			
		Frequency of Maintenance:		0			
RISK CODE:	D	Priority Score:		4			
		Total Score:	8				
Comments:	95091/35				Material Status Change: No Change

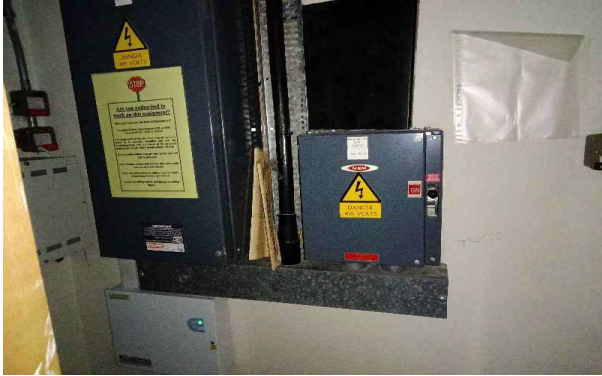
Item / Inspection Ref:	#16	Material Assessment	Product type:	2

Sample Ref:			Condition / Damage:	0			
Survey date:	30/10/2024 - 04/11/2024		Surface Treatment:	2			
Date last inspected:	14/11/2023 12:18:36		Asbestos Type:	1			
Next inspection due:	30th October 2025		Material Score:	5			
Building:	Morrison Nucleus Block Ground Floor		Priority Assessment	Occupant Activity:		1	
Floor level:	Ground Floor			Location:		2	
Room:	C/D Wards 009 (C/D009)			Accessibility:		0	
Position:	Electrics			Extent/amount:		0	Small amounts
Item Description:	Textile Gaskets			Number of Occupants:		1	
Level of Identification:	PRESUMED	Frequency of Use:		3			
Action:	Monitor and manage	Time in Area:		0			
		Maintenance activity:		0			
		Frequency of Maintenance:		0			
RISK CODE:	C	Priority Score:		4			
		Total Score:	9				
Comments:	95091/101				Material Status Change: No Change

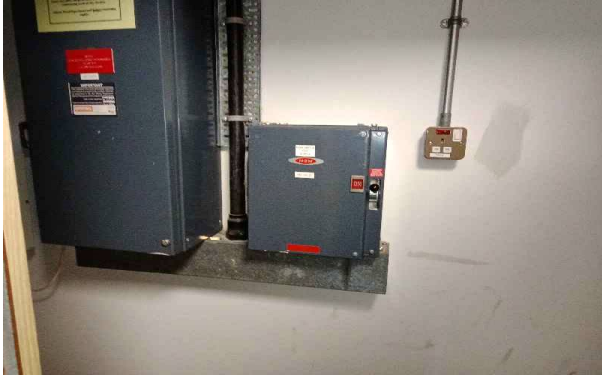
Item / Inspection Ref:	#17	Material Assessment	Product type:	2

Sample Ref:			Condition / Damage:	0			
Survey date:	30/10/2024 - 04/11/2024		Surface Treatment:	2			
Date last inspected:	14/11/2023 12:19:35		Asbestos Type:	1			
Next inspection due:	30th October 2025		Material Score:	5			
Building:	Morrison Nucleus Block Ground Floor		Priority Assessment	Occupant Activity:		1	
Floor level:	Ground Floor			Location:		2	
Room:	C/D Wards 010 (C/D010)			Accessibility:		0	
Position:	Electrics			Extent/amount:		0	Small amounts
Item Description:	Textile Gaskets			Number of Occupants:		1	
Level of Identification:	PRESUMED	Frequency of Use:		3			
Action:	Monitor and manage	Time in Area:		0			
		Maintenance activity:		0			
		Frequency of Maintenance:		0			
RISK CODE:	C	Priority Score:		4			
		Total Score:	9				
Comments:	95091/100				Material Status Change: No Change

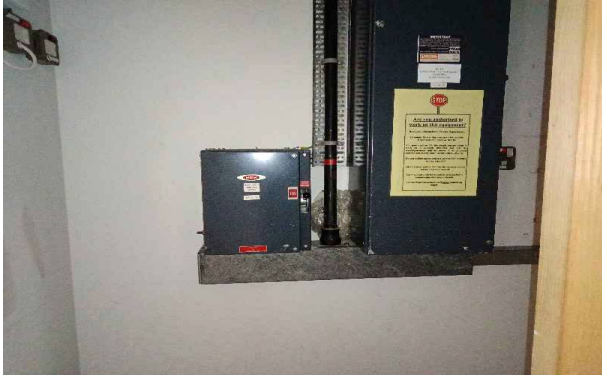
Item / Inspection Ref:	#18	Material Assessment	Product type:	2

Sample Ref:			Condition / Damage:	0		
Survey date:	30/10/2024 - 04/11/2024		Surface Treatment:	2		
Date last inspected:	14/11/2023 12:20:22		Asbestos Type:	1		
Next inspection due:	30th October 2025		Material Score:	5		
Building:	Morrison Nucleus Block Ground Floor	Priority Assessment	Occupant Activity:	1		
Floor level:	Ground Floor		Location:	2		
Room:	CDMU 021 (CDMU021)		Accessibility:	0		
Position:	Electrics		Extent/amount:	0		Small amounts
Item Description:	Textile Gaskets		Number of Occupants:	1		
Level of Identification:	PRESUMED		Frequency of Use:	3		
Action:	Monitor and manage		Time in Area:	0		
RISK CODE:	C	Maintenance activity:	0			
		Frequency of Maintenance:	0			
		Priority Score:	4			
		Total Score:	9			
Comments:	95091/85				Material Status Change: No Change

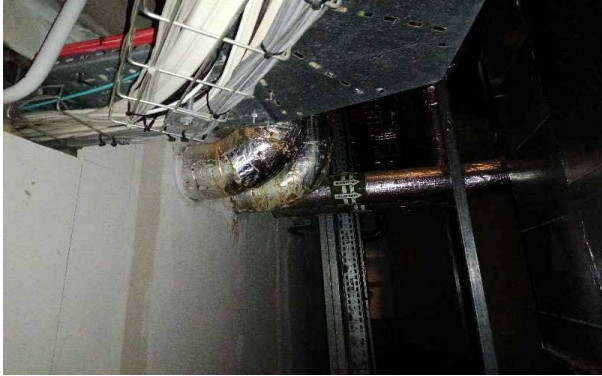
Item / Inspection Ref:	#19	Material Assessment	Product type:	2

Sample Ref:			Condition / Damage:	0		
Survey date:	30/10/2024 - 04/11/2024		Surface Treatment:	2		
Date last inspected:	14/11/2023 12:21:02		Asbestos Type:	1		
Next inspection due:	30th October 2025		Material Score:	5		
Building:	Morrison Nucleus Block Ground Floor	Priority Assessment	Occupant Activity:	1		
Floor level:	Ground Floor		Location:	2		
Room:	CDMU 022 (CDMU 022)		Accessibility:	0		
Position:	Electrics		Extent/amount:	0		Small amounts
Item Description:	Textile Gaskets		Number of Occupants:	1		
Level of Identification:	PRESUMED		Frequency of Use:	3		
Action:	Monitor and manage		Time in Area:	0		
RISK CODE:	C	Maintenance activity:	0			
		Frequency of Maintenance:	0			
		Priority Score:	4			
		Total Score:	9			
Comments:	95091/86				Material Status Change: No Change

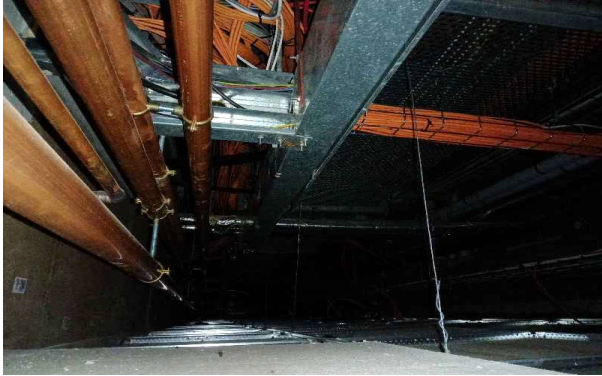
Item / Inspection Ref:	#28	Material Assessment	Product type:	2

Sample Ref:			Condition / Damage:	0			
Survey date:	30/10/2024 - 04/11/2024		Surface Treatment:	1			
Date last inspected:	14/11/2023 12:30:06		Asbestos Type:	1			
Next inspection due:	30th October 2025		Material Score:	4			
Building:	Morrison Nucleus Block Ground Floor		Priority Assessment	Occupant Activity:		1	
Floor level:	Ground Floor			Location:		2	
Room:	Hospital Street 01 (HS01)			Accessibility:		0	
Position:	Ceiling Void			Extent/amount:		0	Small amounts
Item Description:	Textile Gaskets			Number of Occupants:		1	
Level of Identification:	PRESUMED	Frequency of Use:		3			
Action:	Monitor and manage	Time in Area:		0			
		Maintenance activity:		0			
		Frequency of Maintenance:		0			
RISK CODE:	D	Priority Score:		4			
		Total Score:	8				
Comments:	95091/30				Material Status Change: No Change

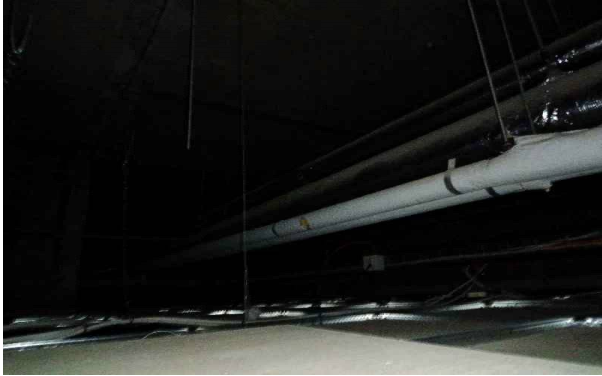
Item / Inspection Ref:	#29	Material Assessment	Product type:	2

Sample Ref:			Condition / Damage:	0			
Survey date:	30/10/2024 - 04/11/2024		Surface Treatment:	1			
Date last inspected:	14/11/2023 12:31:00		Asbestos Type:	1			
Next inspection due:	30th October 2025		Material Score:	4			
Building:	Morrison Nucleus Block Ground Floor		Priority Assessment	Occupant Activity:		1	
Floor level:	Ground Floor			Location:		2	
Room:	Hospital Street 02 (HS02)			Accessibility:		0	
Position:	Ceiling Void			Extent/amount:		0	Small amounts
Item Description:	Textile Gaskets			Number of Occupants:		1	
Level of Identification:	PRESUMED	Frequency of Use:		3			
Action:	Monitor and manage	Time in Area:		0			
		Maintenance activity:		0			
		Frequency of Maintenance:		0			
RISK CODE:	D	Priority Score:		4			
		Total Score:	8				
Comments:	95091/31				Material Status Change: No Change

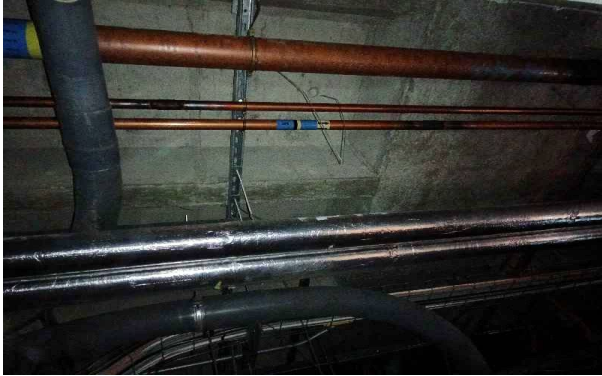
Item / Inspection Ref:	#30	Material Assessment	Product type:	2

Sample Ref:			Condition / Damage:	0			
Survey date:	30/10/2024 - 04/11/2024		Surface Treatment:	1			
Date last inspected:	14/11/2023 12:31:37		Asbestos Type:	1			
Next inspection due:	30th October 2025		Material Score:	4			
Building:	Morrison Nucleus Block Ground Floor		Priority Assessment	Occupant Activity:		1	
Floor level:	Ground Floor			Location:		2	
Room:	Hospital Street 03 (HS03)			Accessibility:		0	
Position:	Ceiling Void			Extent/amount:		0	Small amounts
Item Description:	Textile Gaskets			Number of Occupants:		1	
Level of Identification:	PRESUMED			Frequency of Use:		3	
Action:	Monitor and manage			Time in Area:		0	
		Maintenance activity:		0			
RISK CODE:	D	Frequency of Maintenance:	0				
		Priority Score:	4				
Comments:	95091/32	Total Score:	8	Material Status Change:			
				No Change

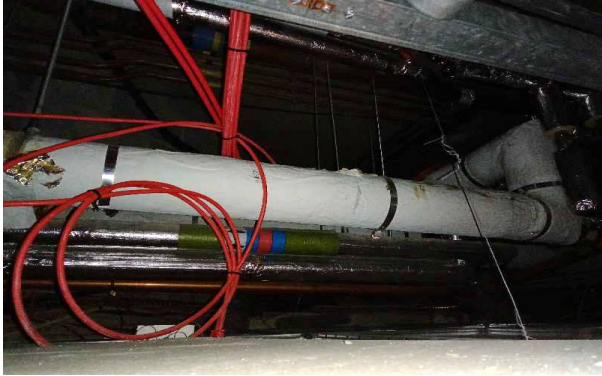
Item / Inspection Ref:	#31	Material Assessment	Product type:	2

Sample Ref:			Condition / Damage:	0			
Survey date:	30/10/2024 - 04/11/2024		Surface Treatment:	1			
Date last inspected:	14/11/2023 12:32:08		Asbestos Type:	1			
Next inspection due:	30th October 2025		Material Score:	4			
Building:	Morrison Nucleus Block Ground Floor		Priority Assessment	Occupant Activity:		1	
Floor level:	Ground Floor			Location:		2	
Room:	Hospital Street 04 (HS04)			Accessibility:		0	
Position:	Ceiling Void			Extent/amount:		0	Small amounts
Item Description:	Textile Gaskets			Number of Occupants:		1	
Level of Identification:	PRESUMED			Frequency of Use:		3	
Action:	Monitor and manage			Time in Area:		0	
		Maintenance activity:		0			
RISK CODE:	D	Frequency of Maintenance:	0				
		Priority Score:	4				
Comments:	95091/33	Total Score:	8	Material Status Change:			
				No Change

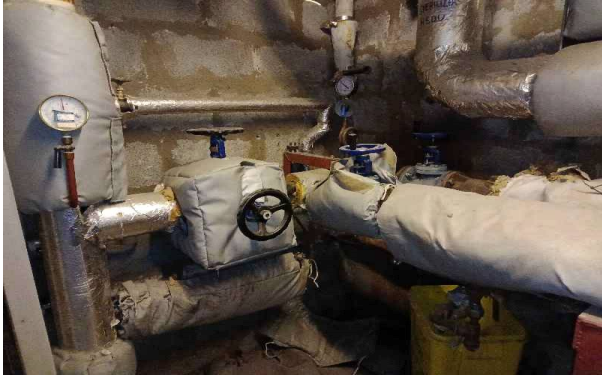
Item / Inspection Ref:	#32	Material Assessment	Product type:	2

Sample Ref:			Condition / Damage:	0			
Survey date:	30/10/2024 - 04/11/2024		Surface Treatment:	1			
Date last inspected:	14/11/2023 12:33:35		Asbestos Type:	1			
Next inspection due:	30th October 2025		Material Score:	4			
Building:	Morrison Nucleus Block Ground Floor		Priority Assessment	Occupant Activity:		1	
Floor level:	Ground Floor			Location:		2	
Room:	Hotel Services 001 (HSRV001)			Accessibility:		0	
Position:	Ceiling Void			Extent/amount:		0	Small amounts
Item Description:	Textile Gaskets			Number of Occupants:		1	
Level of Identification:	PRESUMED	Frequency of Use:		3			
Action:	Monitor and manage	Time in Area:		0			
		Maintenance activity:		0			
		Frequency of Maintenance:		0			
RISK CODE:	D	Priority Score:		4			
		Total Score:	8				
Comments:	95091/43 & 84				Material Status Change: No Change

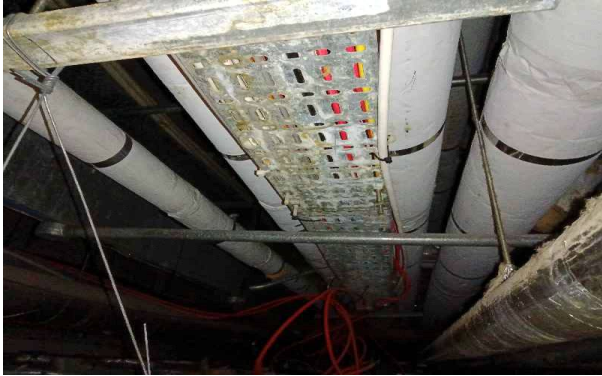
Item / Inspection Ref:	#34	Material Assessment	Product type:	2

Sample Ref:			Condition / Damage:	0		
Survey date:	30/10/2024 - 04/11/2024		Surface Treatment:	1		
Date last inspected:	14/11/2023 12:35:40		Asbestos Type:	1		
Next inspection due:	30th October 2025		Material Score:	4		
Building:	Morrison Nucleus Block Ground Floor	Priority Assessment	Occupant Activity:	1		
Floor level:	Ground Floor		Location:	2		
Room:	Hotel Services 020 (HSRV020)		Accessibility:	0		
Position:	Pipework		Extent/amount:	0		Small amounts

Item Description:	Textile Gaskets		Number of Occupants:	1		
Level of Identification:	PRESUMED		Frequency of Use:	3		
Action:	Monitor and manage		Time in Area:	0		
			Maintenance activity:	0		
RISK CODE:	D	Frequency of Maintenance:	0			
		Priority Score:	4			
		Total Score:	8			
Comments:	95091/42 Unable to locate pipework gaskets in location marked on plan. Presumed to remain,				Material Status Change: Unable to Locate

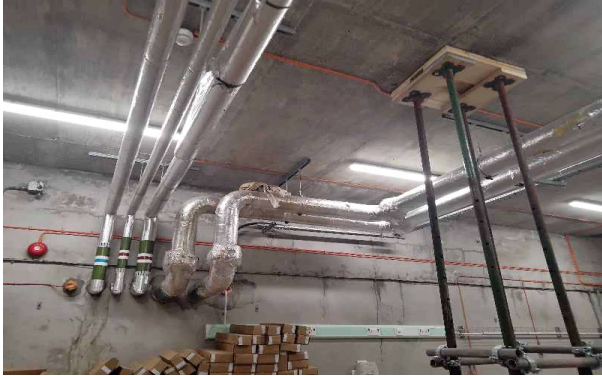
Item / Inspection Ref:	#37	Material Assessment	Product type:	2

Sample Ref:	676060224 {ZC002073}		Condition / Damage:	1		
Survey date:	30/10/2024 - 04/11/2024		Surface Treatment:	1		
Date last inspected:	14/11/2023 12:38:20		Asbestos Type:	1		
Next inspection due:	30th October 2025		Material Score:	5		
Building:	Morrison Nucleus Block Ground Floor	Priority Assessment	Occupant Activity:	1		
Floor level:	Ground Floor		Location:	2		
Room:	Hotel Services 028 (HSRV028)		Accessibility:	0		
Position:	Ceiling Void		Extent/amount:	0		Small amounts
Item Description:	Textile Gaskets		Number of Occupants:	1		
Level of Identification:	SAMPLED		Frequency of Use:	3		
Action:	Monitor and manage		Time in Area:	0		
RISK CODE:	C	Maintenance activity:	0			
		Frequency of Maintenance:	0			
		Priority Score:	4			
		Total Score:	9			
Comments:	95091/46				Material Status Change:	
					No Change

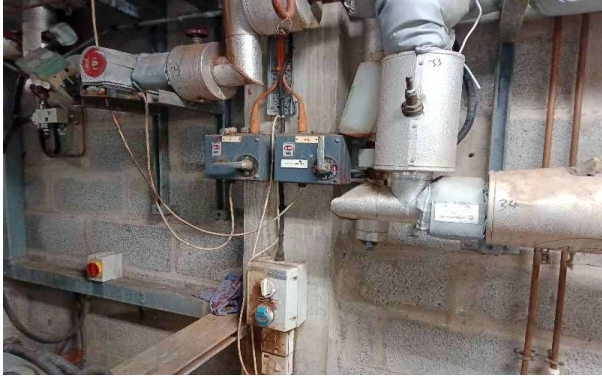
Item / Inspection Ref:	#38	Material Assessment	Product type:	2

Sample Ref:			Condition / Damage:	0			
Survey date:	30/10/2024 - 04/11/2024		Surface Treatment:	1			
Date last inspected:	14/11/2023 12:39:11		Asbestos Type:	1			
Next inspection due:	30th October 2025		Material Score:	4			
Building:	Morrison Nucleus Block Ground Floor		Priority Assessment	Occupant Activity:		1	
Floor level:	Ground Floor			Location:		2	
Room:	Hotel Services 035 (HSRV035)			Accessibility:		0	
Position:	Pipework			Extent/amount:		0	Small amounts

Item Description:	Textile Gaskets			Number of Occupants:		1	
Level of Identification:	PRESUMED	Frequency of Use:		3			
Action:	Monitor and manage	Time in Area:		0			
		Maintenance activity:		0			
		Frequency of Maintenance:		0			
RISK CODE:	D	Priority Score:		4			
		Total Score:	8				
Comments:	95091/45 Unable to access location. Presumed to remain.			Material Status Change:	Unable to Access

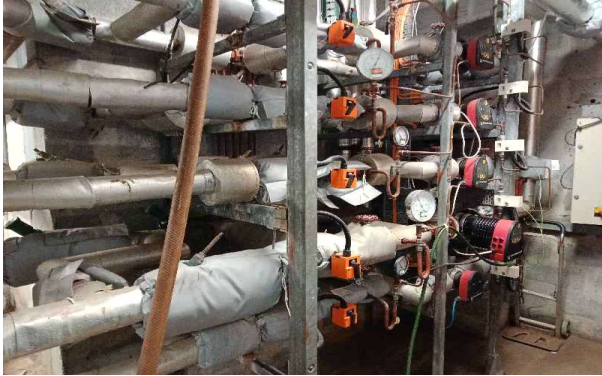
Item / Inspection Ref:	#39	Material Assessment	Product type:	2

Sample Ref:			Condition / Damage:	0			
Survey date:	30/10/2024 - 04/11/2024		Surface Treatment:	1			
Date last inspected:	14/11/2023 12:41:04		Asbestos Type:	1			
Next inspection due:	30th October 2025		Material Score:	4			
Building:	Morrison Nucleus Block Ground Floor		Priority Assessment	Occupant Activity:		1	
Floor level:	Ground Floor			Location:		2	
Room:	Hotel Services 036 (HSRV036)			Accessibility:		0	
Position:	Pipework			Extent/amount:		0	Small amounts
Item Description:	Textile Gaskets			Number of Occupants:		1	
Level of Identification:	PRESUMED	Frequency of Use:		3			
Action:	Monitor and manage	Time in Area:		0			
		Maintenance activity:		0			
		Frequency of Maintenance:		0			
RISK CODE:	D	Priority Score:		4			
		Total Score:	8				
Comments:	95091/70				Material Status Change: No Change

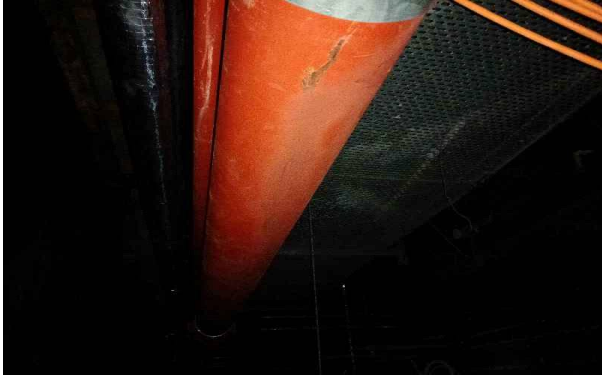
Item / Inspection Ref:	#40	Material Assessment	Product type:	2

Sample Ref:			Condition / Damage:	0			
Survey date:	30/10/2024 - 04/11/2024		Surface Treatment:	1			
Date last inspected:	14/11/2023 12:43:07		Asbestos Type:	1			
Next inspection due:	30th October 2025		Material Score:	4			
Building:	Morrison Nucleus Block Ground Floor		Priority Assessment	Occupant Activity:		1	
Floor level:	Ground Floor			Location:		2	
Room:	Main Street 01 (MS01)			Accessibility:		0	
Position:	Ceiling Void			Extent/amount:		0	Small amounts
Item Description:	Textile Gaskets			Number of Occupants:		1	
Level of Identification:	PRESUMED	Frequency of Use:		3			
Action:	Monitor and manage	Time in Area:		0			
		Maintenance activity:		0			
		Frequency of Maintenance:		0			
RISK CODE:	D	Priority Score:		4			
		Total Score:	8				
Comments:	95091/02				Material Status Change: No Change

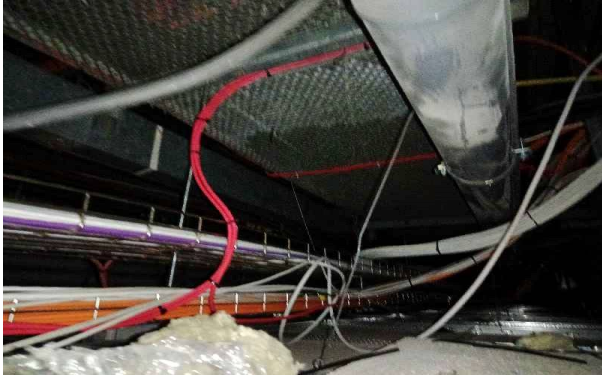
Item / Inspection Ref:	#44	Material Assessment	Product type:	2

Sample Ref:			Condition / Damage:	0			
Survey date:	30/10/2024 - 04/11/2024		Surface Treatment:	1			
Date last inspected:	14/11/2023 12:45:33		Asbestos Type:	1			
Next inspection due:	30th October 2025		Material Score:	4			
Building:	Morrison Nucleus Block Ground Floor		Priority Assessment	Occupant Activity:		1	
Floor level:	Ground Floor			Location:		2	
Room:	Main Street 04 (MS04)			Accessibility:		0	
Position:	Ceiling Void			Extent/amount:		0	Small amounts
Item Description:	Textile Gaskets			Number of Occupants:		1	
Level of Identification:	PRESUMED	Frequency of Use:		3			
Action:	Monitor and manage	Time in Area:		0			
		Maintenance activity:		0			
		Frequency of Maintenance:		0			
RISK CODE:	D	Priority Score:		4			
		Total Score:	8				
Comments:	95091/17				Material Status Change: No Change

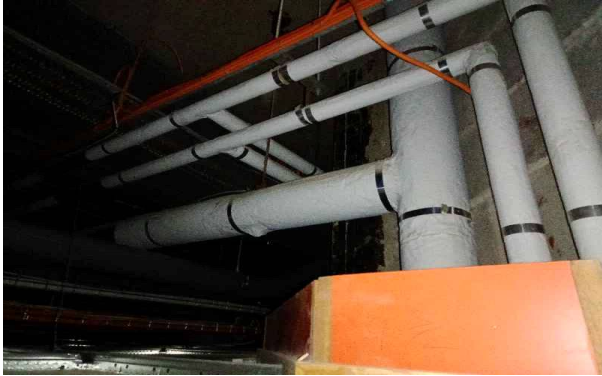
Item / Inspection Ref:	#45	Material Assessment	Product type:	2

Sample Ref:			Condition / Damage:	0		
Survey date:	30/10/2024 - 04/11/2024		Surface Treatment:	1		
Date last inspected:	14/11/2023 12:46:03		Asbestos Type:	1		
Next inspection due:	30th October 2025		Material Score:	4		
Building:	Morrison Nucleus Block Ground Floor	Priority Assessment	Occupant Activity:	1		
Floor level:	Ground Floor		Location:	2		
Room:	Main Street 05 (MS05)		Accessibility:	0		
Position:	Ceiling Void		Extent/amount:	0		Small amounts
Item Description:	Textile Gaskets		Number of Occupants:	1		
Level of Identification:	PRESUMED		Frequency of Use:	3		
Action:	Monitor and manage		Time in Area:	0		
			Maintenance activity:	0		
RISK CODE:	D	Frequency of Maintenance:	0			
		Priority Score:	4			
Comments:	95091/19	Total Score:	8	Material Status Change:		
				No Change

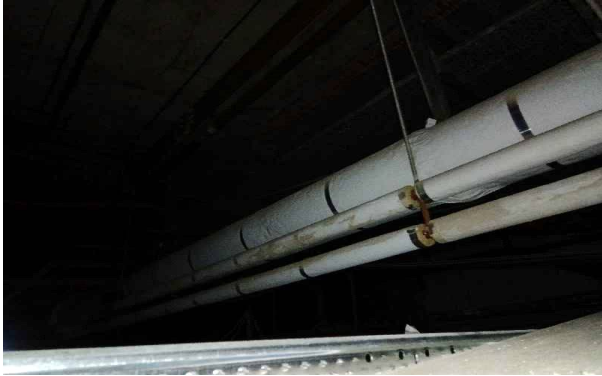
Item / Inspection Ref:	#46	Material Assessment	Product type:	2

Sample Ref:			Condition / Damage:	0		
Survey date:	30/10/2024 - 04/11/2024		Surface Treatment:	1		
Date last inspected:	14/11/2023 12:46:42		Asbestos Type:	1		
Next inspection due:	30th October 2025		Material Score:	4		
Building:	Morrison Nucleus Block Ground Floor	Priority Assessment	Occupant Activity:	1		
Floor level:	Ground Floor		Location:	2		
Room:	Main Street 06 (MS06)		Accessibility:	0		
Position:	Ceiling Void		Extent/amount:	0		Small amounts
Item Description:	Textile Gaskets		Number of Occupants:	1		
Level of Identification:	PRESUMED		Frequency of Use:	3		
Action:	Monitor and manage		Time in Area:	0		
			Maintenance activity:	0		
RISK CODE:	D	Frequency of Maintenance:	0			
		Priority Score:	4			
Comments:	95091/20	Total Score:	8	Material Status Change:		
				No Change

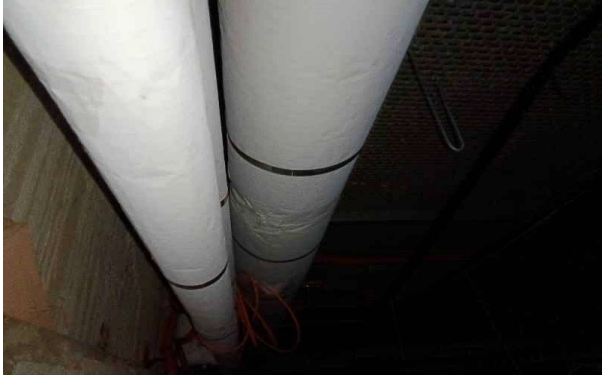
Item / Inspection Ref:	#47	Material Assessment	Product type:	2

Sample Ref:			Condition / Damage:	0		
Survey date:	30/10/2024 - 04/11/2024		Surface Treatment:	1		
Date last inspected:	14/11/2023 12:47:53		Asbestos Type:	1		
Next inspection due:	30th October 2025		Material Score:	4		
Building:	Morrison Nucleus Block Ground Floor	Priority Assessment	Occupant Activity:	1		
Floor level:	Ground Floor		Location:	2		
Room:	Main Street 07 (MS07)		Accessibility:	0		
Position:	Ceiling Void		Extent/amount:	0		Small amounts
Item Description:	Textile Gaskets		Number of Occupants:	1		
Level of Identification:	PRESUMED		Frequency of Use:	3		
Action:	Monitor and manage		Time in Area:	0		
			Maintenance activity:	0		
RISK CODE:	D	Frequency of Maintenance:	0			
		Priority Score:	4			
Comments:	95091/23	Total Score:	8	Material Status Change:		
				No Change

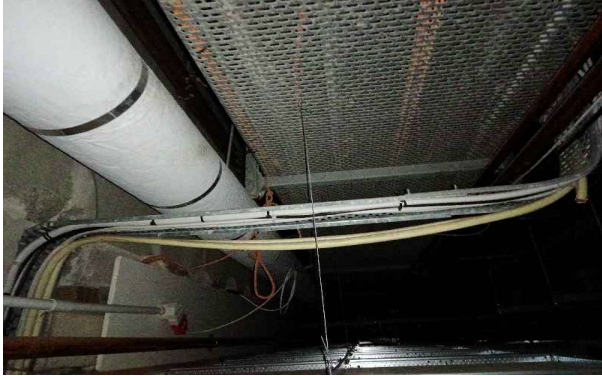
Item / Inspection Ref:	#48	Material Assessment	Product type:	2

Sample Ref:			Condition / Damage:	0		
Survey date:	30/10/2024 - 04/11/2024		Surface Treatment:	1		
Date last inspected:	14/11/2023 12:48:22		Asbestos Type:	1		
Next inspection due:	30th October 2025		Material Score:	4		
Building:	Morrison Nucleus Block Ground Floor	Priority Assessment	Occupant Activity:	1		
Floor level:	Ground Floor		Location:	2		
Room:	Main Street 09 (MS09)		Accessibility:	0		
Position:	Ceiling Void		Extent/amount:	0		Small amounts
Item Description:	Textile Gaskets		Number of Occupants:	1		
Level of Identification:	PRESUMED		Frequency of Use:	3		
Action:	Monitor and manage		Time in Area:	0		
			Maintenance activity:	0		
RISK CODE:	D	Frequency of Maintenance:	0			
		Priority Score:	4			
Comments:	95091/24	Total Score:	8	Material Status Change:		
				No Change

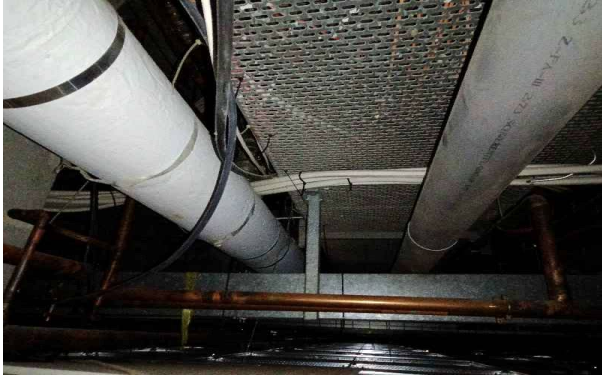
Item / Inspection Ref:	#49	Material Assessment	Product type:	2

Sample Ref:			Condition / Damage:	0			
Survey date:	30/10/2024 - 04/11/2024		Surface Treatment:	1			
Date last inspected:	14/11/2023 12:48:53		Asbestos Type:	1			
Next inspection due:	30th October 2025		Material Score:	4			
Building:	Morrison Nucleus Block Ground Floor		Priority Assessment	Occupant Activity:		1	
Floor level:	Ground Floor			Location:		2	
Room:	Main Street 10 (MS10)			Accessibility:		0	
Position:	Ceiling Void			Extent/amount:		0	Small amounts
Item Description:	Textile Gaskets			Number of Occupants:		1	
Level of Identification:	PRESUMED	Frequency of Use:		3			
Action:	Monitor and manage	Time in Area:		0			
		Maintenance activity:		0			
		Frequency of Maintenance:		0			
RISK CODE:	D	Priority Score:		4			
		Total Score:	8				
Comments:	95091/26				Material Status Change: No Change

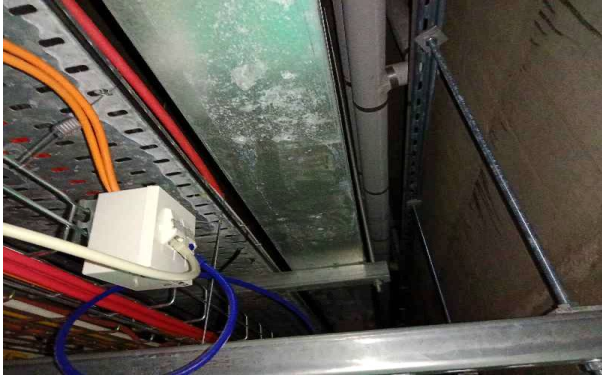
Item / Inspection Ref:	#50	Material Assessment	Product type:	2

Sample Ref:			Condition / Damage:	0			
Survey date:	30/10/2024 - 04/11/2024		Surface Treatment:	1			
Date last inspected:	14/11/2023 12:49:20		Asbestos Type:	1			
Next inspection due:	30th October 2025		Material Score:	4			
Building:	Morrison Nucleus Block Ground Floor		Priority Assessment	Occupant Activity:		1	
Floor level:	Ground Floor			Location:		2	
Room:	Main Street 11 (MS11)			Accessibility:		0	
Position:	Ceiling Void			Extent/amount:		0	Small amounts
Item Description:	Textile Gaskets			Number of Occupants:		1	
Level of Identification:	PRESUMED	Frequency of Use:		3			
Action:	Monitor and manage	Time in Area:		0			
		Maintenance activity:		0			
		Frequency of Maintenance:		0			
RISK CODE:	D	Priority Score:		4			
		Total Score:	8				
Comments:	95091/27				Material Status Change: No Change

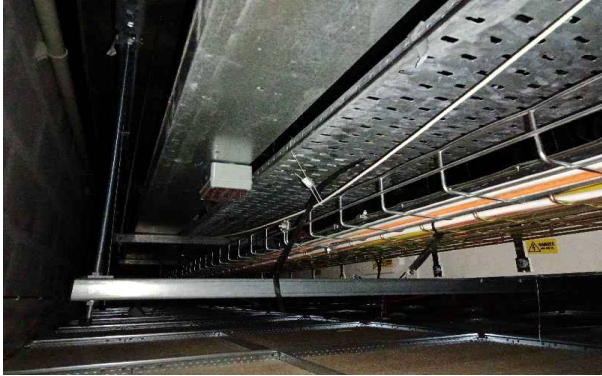
Item / Inspection Ref:	#51	Material Assessment	Product type:	2

Sample Ref:			Condition / Damage:	0			
Survey date:	30/10/2024 - 04/11/2024		Surface Treatment:	1			
Date last inspected:	14/11/2023 12:49:51		Asbestos Type:	1			
Next inspection due:	30th October 2025		Material Score:	4			
Building:	Morrison Nucleus Block Ground Floor		Priority Assessment	Occupant Activity:		1	
Floor level:	Ground Floor			Location:		2	
Room:	Main Street 12 (MS12)			Accessibility:		0	
Position:	Ceiling Void			Extent/amount:		0	Small amounts
Item Description:	Textile Gaskets			Number of Occupants:		1	
Level of Identification:	PRESUMED	Frequency of Use:		3			
Action:	Monitor and manage	Time in Area:		0			
		Maintenance activity:		0			
RISK CODE:	D	Frequency of Maintenance:	0				
		Priority Score:	4				
Comments:	95091/28	Total Score:	8	Material Status Change:			
				No Change

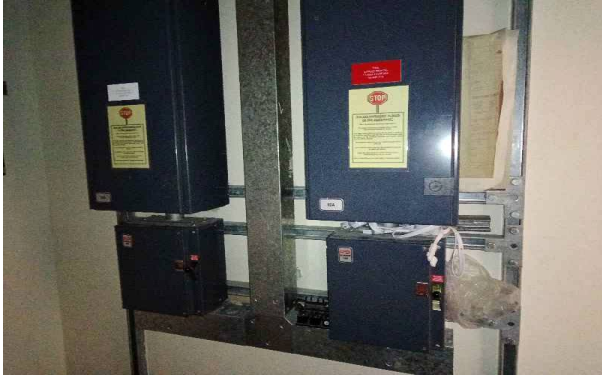
Item / Inspection Ref:	#52	Material Assessment	Product type:	2

Sample Ref:			Condition / Damage:	0			
Survey date:	30/10/2024 - 04/11/2024		Surface Treatment:	2			
Date last inspected:	14/11/2023 12:50:54		Asbestos Type:	1			
Next inspection due:	30th October 2025		Material Score:	5			
Building:	Morrison Nucleus Block Ground Floor		Priority Assessment	Occupant Activity:		1	
Floor level:	Ground Floor			Location:		2	
Room:	Plastic / Burns 051 (P/B051)			Accessibility:		0	
Position:	Electrics			Extent/amount:		0	Small amounts
Item Description:	Textile Gaskets			Number of Occupants:		1	
Level of Identification:	PRESUMED	Frequency of Use:		3			
Action:	Monitor and manage	Time in Area:		0			
		Maintenance activity:		0			
RISK CODE:	C	Frequency of Maintenance:	0				
		Priority Score:	4				
Comments:	95091/98	Total Score:	9	Material Status Change:			
				No Change

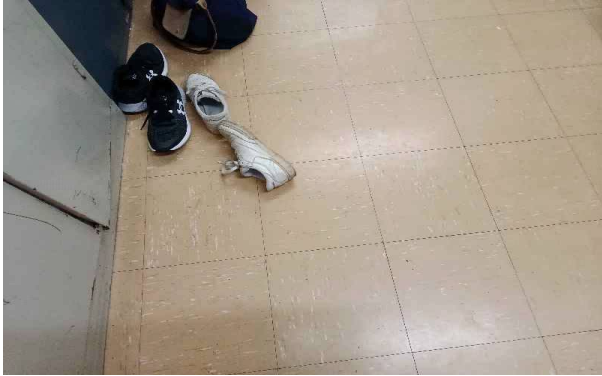
Item / Inspection Ref:	#54	Material Assessment	Product type:	1

Sample Ref:			Condition / Damage:	0			
Survey date:	30/10/2024 - 04/11/2024		Surface Treatment:	0			
Date last inspected:	14/11/2023 12:52:24		Asbestos Type:	1			
Next inspection due:	30th October 2025		Material Score:	2			
Building:	Morrison Nucleus Block Ground Floor		Priority Assessment	Occupant Activity:		1	
Floor level:	Ground Floor			Location:		2	
Room:	Rehab 013 (R013)			Accessibility:		1	
Position:	Floor			Extent/amount:		2	10-50m ²
Item Description:	Floor Tiles and Adhesive			Number of Occupants:		1	
Level of Identification:	PRESUMED	Frequency of Use:		3			
Action:	Monitor and manage	Time in Area:		0			
		Maintenance activity:		0			
		Frequency of Maintenance:		0			
RISK CODE:	D	Priority Score:		5			
		Total Score:	7				
Comments:	95091/82				Material Status Change: No Change

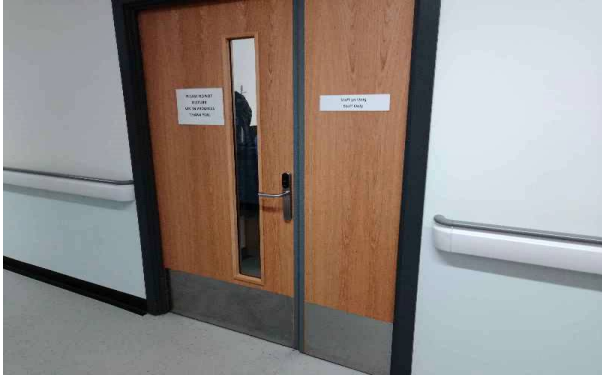
Item / Inspection Ref:	#57	Material Assessment	Product type:	1

Sample Ref:			Condition / Damage:	0			
Survey date:	30/10/2024 - 04/11/2024		Surface Treatment:	0			
Date last inspected:	14/11/2023 12:54:32		Asbestos Type:	1			
Next inspection due:	30th October 2025		Material Score:	2			
Building:	Morrison Nucleus Block Ground Floor		Priority Assessment	Occupant Activity:		1	
Floor level:	Ground Floor			Location:		2	
Room:	Rehab 036 (R036)			Accessibility:		0	
Position:	To Sink			Extent/amount:		0	Small amounts

Item Description:	Sink Pad			Number of Occupants:		1	
Level of Identification:	PRESUMED	Frequency of Use:		3			
Action:	Monitor and manage	Time in Area:		0			
		Maintenance activity:		0			
RISK CODE:	D	Frequency of Maintenance:	0				
		Priority Score:	4				
Comments:	95091/77 Unable to locate sink. Room has potentially been refurbished.	Total Score:	6	Material Status Change:			
				Unable to Locate

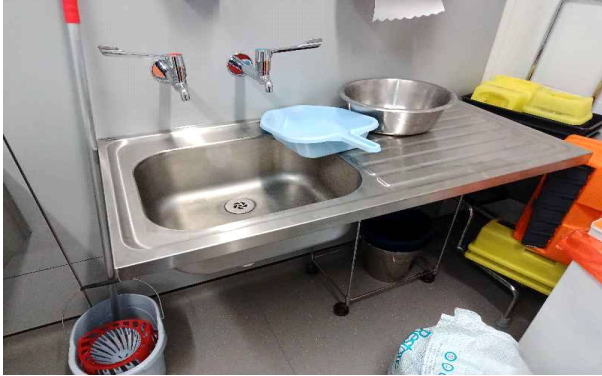
Item / Inspection Ref:	#58	Material Assessment	Product type:	1

Sample Ref:	611950221 {ZC002074}		Condition / Damage:	0			
Survey date:	30/10/2024 - 04/11/2024		Surface Treatment:	0			
Date last inspected:	14/11/2023 12:55:19		Asbestos Type:	1			
Next inspection due:	30th October 2025		Material Score:	2			
Building:	Morrison Nucleus Block Ground Floor		Priority Assessment	Occupant Activity:		1	
Floor level:	Ground Floor			Location:		2	
Room:	Rehab 038 (R038)			Accessibility:		0	
Position:	To Sink			Extent/amount:		0	Small amounts
Item Description:	Sink Pad			Number of Occupants:		1	
Level of Identification:	SAMPLED	Frequency of Use:		3			
Action:	Monitor and manage	Time in Area:		0			
		Maintenance activity:		0			
RISK CODE:	D	Frequency of Maintenance:	0				
		Priority Score:	4				
Comments:	95091/76	Total Score:	6	Material Status Change:			
				No Change

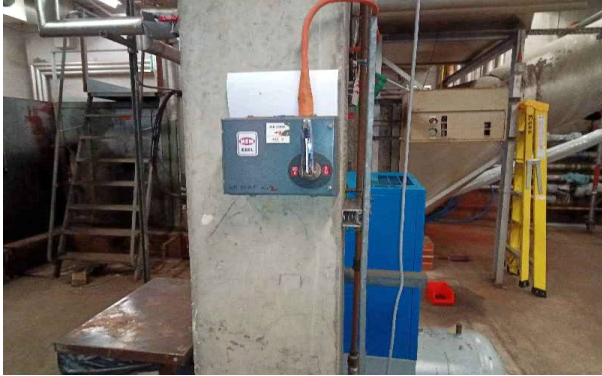
Item / Inspection Ref:	#60	Material Assessment	Product type:	2

Sample Ref:			Condition / Damage:	0			
Survey date:	30/10/2024 - 04/11/2024		Surface Treatment:	2			
Date last inspected:	14/11/2023 12:58:18		Asbestos Type:	1			
Next inspection due:	30th October 2025		Material Score:	5			
Building:	Morrison Nucleus Block Ground Floor		Priority Assessment	Occupant Activity:		1	
Floor level:	Ground Floor			Location:		2	
Room:	SC GF 030 (SCGF030)			Accessibility:		0	
Position:	Electrics			Extent/amount:		0	Small amounts
Item Description:	Textile Gaskets			Number of Occupants:		1	
Level of Identification:	PRESUMED	Frequency of Use:		3			
Action:	Monitor and manage	Time in Area:		0			
		Maintenance activity:		0			
		Frequency of Maintenance:		0			
RISK CODE:	C	Priority Score:		4			
		Total Score:	9				
Comments:	95091/72			Material Status Change:	No Change

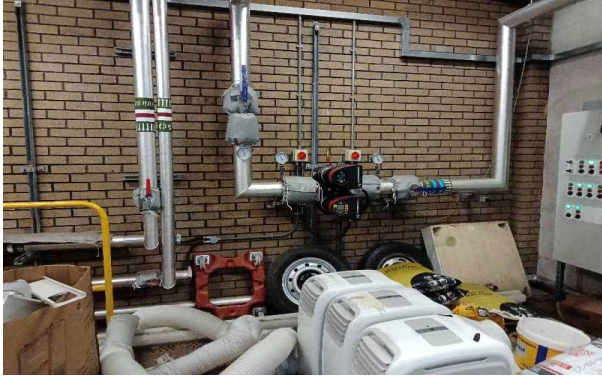
Item / Inspection Ref:	#61	Material Assessment	Product type:	2

Sample Ref:			Condition / Damage:	0			
Survey date:	30/10/2024 - 04/11/2024		Surface Treatment:	1			
Date last inspected:	14/11/2023 12:58:41		Asbestos Type:	1			
Next inspection due:	30th October 2025		Material Score:	4			
Building:	Morrison Nucleus Block Ground Floor		Priority Assessment	Occupant Activity:		1	
Floor level:	Ground Floor			Location:		2	
Room:	SC GF 030 (SCGF030)			Accessibility:		0	
Position:	Pipework			Extent/amount:		0	Small amounts

Item Description:	Textile Gaskets			Number of Occupants:		1	
Level of Identification:	PRESUMED	Frequency of Use:		3			
Action:	Monitor and manage	Time in Area:		0			
		Maintenance activity:		0			
		Frequency of Maintenance:		0			
RISK CODE:	D	Priority Score:		4			
		Total Score:	8				
Comments:	95091/71. There are also many stored items present in the room that may harbour gaskets or packing material.			Material Status Change:	No Change

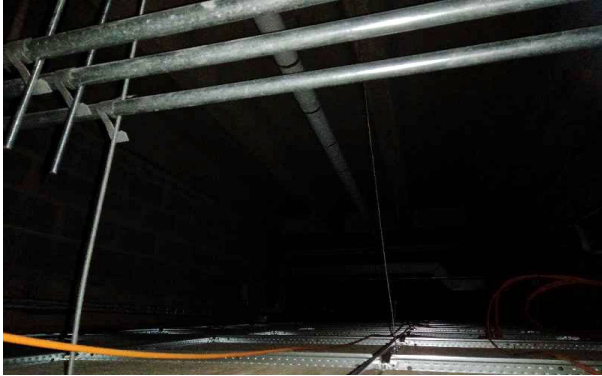
Item / Inspection Ref:	#62	Material Assessment	Product type:	2

Sample Ref:			Condition / Damage:	0			
Survey date:	30/10/2024 - 04/11/2024		Surface Treatment:	1			
Date last inspected:	14/11/2023 13:00:11		Asbestos Type:	1			
Next inspection due:	30th October 2025		Material Score:	4			
Building:	Morrison Nucleus Block Ground Floor		Priority Assessment	Occupant Activity:		1	
Floor level:	Ground Floor			Location:		2	
Room:	SC PH 001 (SCPH001)			Accessibility:		0	
Position:	Ceiling Void			Extent/amount:		0	Small amounts
Item Description:	Textile Gaskets			Number of Occupants:		1	
Level of Identification:	PRESUMED	Frequency of Use:		3			
Action:	Monitor and manage	Time in Area:		0			
		Maintenance activity:		0			
		Frequency of Maintenance:		0			
RISK CODE:	D	Priority Score:		4			
		Total Score:	8				
Comments:	95091/29			Material Status Change:	No Change

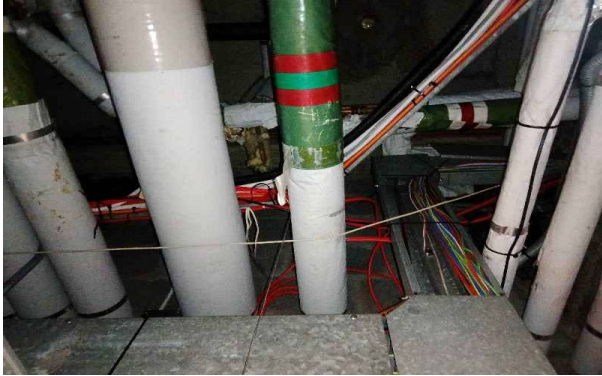
Item / Inspection Ref:	#63	Material Assessment	Product type:	2

Sample Ref:			Condition / Damage:	0			
Survey date:	30/10/2024 - 04/11/2024		Surface Treatment:	1			
Date last inspected:	14/11/2023 13:00:44		Asbestos Type:	1			
Next inspection due:	30th October 2025		Material Score:	4			
Building:	Morrison Nucleus Block Ground Floor		Priority Assessment	Occupant Activity:		1	
Floor level:	Ground Floor			Location:		2	
Room:	SC PH 010 (SCPH010)			Accessibility:		0	
Position:	Ceiling Void			Extent/amount:		0	Small amounts
Item Description:	Textile Gaskets			Number of Occupants:		1	
Level of Identification:	PRESUMED	Frequency of Use:		3			
Action:	Monitor and manage	Time in Area:		0			
		Maintenance activity:		0			
		Frequency of Maintenance:		0			
RISK CODE:	D	Priority Score:		4			
		Total Score:	8				
Comments:	95091/54	Material Status Change:					
		No Change

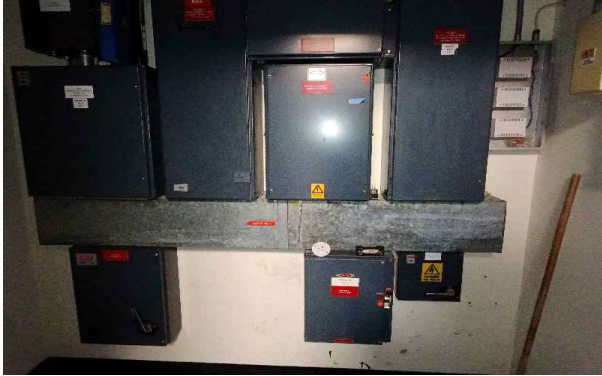
Item / Inspection Ref:	#64	Material Assessment	Product type:	2

Sample Ref:			Condition / Damage:	0			
Survey date:	30/10/2024 - 04/11/2024		Surface Treatment:	2			
Date last inspected:	14/11/2023 13:03:20		Asbestos Type:	1			
Next inspection due:	30th October 2025		Material Score:	5			
Building:	Morrison Nucleus Block Ground Floor		Priority Assessment	Occupant Activity:		1	
Floor level:	Ground Floor			Location:		2	
Room:	SC PH 012 (SCPH012)			Accessibility:		0	
Position:	Electrics			Extent/amount:		0	Small amounts
Item Description:	Textile Gaskets			Number of Occupants:		1	
Level of Identification:	PRESUMED	Frequency of Use:		3			
Action:	Monitor and manage	Time in Area:		0			
		Maintenance activity:		0			
		Frequency of Maintenance:		0			
RISK CODE:	C	Priority Score:		4			
		Total Score:	9				
Comments:	95091/56	Material Status Change:					
		No Change

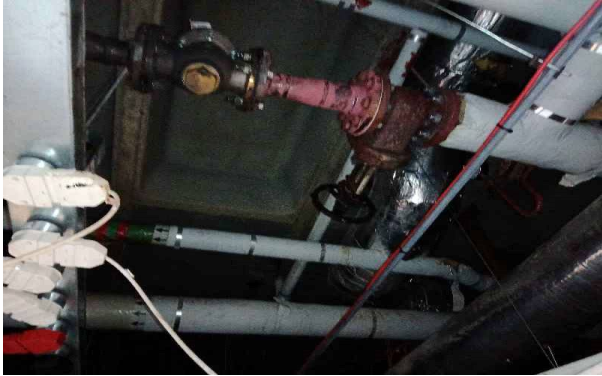
Item / Inspection Ref:	#65	Material Assessment	Product type:	2

Sample Ref:			Condition / Damage:	0			
Survey date:	30/10/2024 - 04/11/2024		Surface Treatment:	1			
Date last inspected:	14/11/2023 13:03:58		Asbestos Type:	1			
Next inspection due:	30th October 2025		Material Score:	4			
Building:	Morrison Nucleus Block Ground Floor		Priority Assessment	Occupant Activity:		1	
Floor level:	Ground Floor			Location:		2	
Room:	SC PH 020 (SCPH020)			Accessibility:		0	
Position:	Ceiling Void			Extent/amount:		0	Small amounts

Item Description:	Textile Gaskets			Number of Occupants:		1	
Level of Identification:	PRESUMED	Frequency of Use:		3			
Action:	Monitor and manage	Time in Area:		0			
		Maintenance activity:		0			
		Frequency of Maintenance:		0			
RISK CODE:	D	Priority Score:		4			
		Total Score:	8				
Comments:	95091/50. Potential gland packing also present.			Material Status Change:	No Change

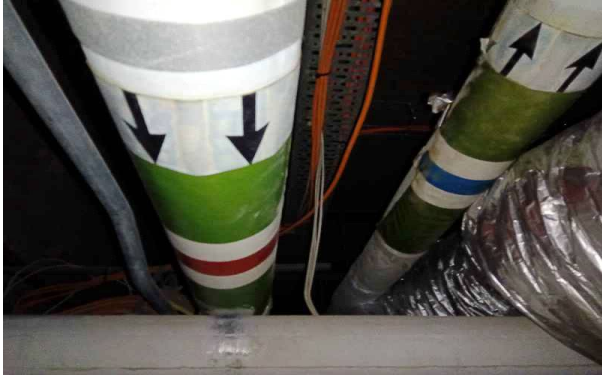
Item / Inspection Ref:	#66	Material Assessment	Product type:	2

Sample Ref:			Condition / Damage:	0			
Survey date:	30/10/2024 - 04/11/2024		Surface Treatment:	1			
Date last inspected:	14/11/2023 13:05:07		Asbestos Type:	1			
Next inspection due:	30th October 2025		Material Score:	4			
Building:	Morrison Nucleus Block Ground Floor		Priority Assessment	Occupant Activity:		1	
Floor level:	Ground Floor			Location:		2	
Room:	SC PH 023 (SCPH023)			Accessibility:		0	
Position:	Ceiling Void			Extent/amount:		0	Small amounts
Item Description:	Textile Gaskets			Number of Occupants:		1	
Level of Identification:	PRESUMED	Frequency of Use:		3			
Action:	Monitor and manage	Time in Area:		0			
		Maintenance activity:		0			
		Frequency of Maintenance:		0			
RISK CODE:	D	Priority Score:		4			
		Total Score:	8				
Comments:	95091/51			Material Status Change:	No Change

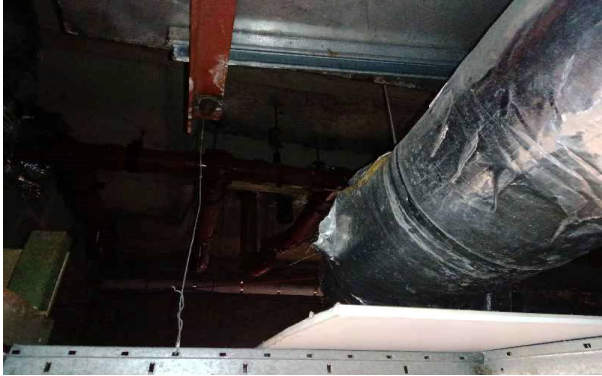
Item / Inspection Ref:	#67	Material Assessment	Product type:	2

Sample Ref:			Condition / Damage:	0			
Survey date:	30/10/2024 - 04/11/2024		Surface Treatment:	1			
Date last inspected:	14/11/2023 13:06:22		Asbestos Type:	1			
Next inspection due:	30th October 2025		Material Score:	4			
Building:	Morrison Nucleus Block Ground Floor		Priority Assessment	Occupant Activity:		1	
Floor level:	Ground Floor			Location:		2	
Room:	SC PH 026 (SCPH026)			Accessibility:		0	
Position:	Ceiling Void			Extent/amount:		0	Small amounts
Item Description:	Textile Gaskets			Number of Occupants:		1	
Level of Identification:	PRESUMED	Frequency of Use:		3			
Action:	Monitor and manage	Time in Area:		0			
		Maintenance activity:		0			
RISK CODE:	D	Frequency of Maintenance:		0			
		Priority Score:		4			
Comments:	95091/52	Total Score:	8	Material Status Change:			
				No Change

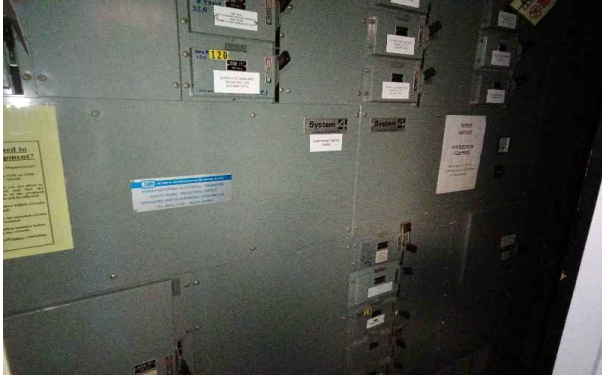
Item / Inspection Ref:	#68	Material Assessment	Product type:	2

Sample Ref:			Condition / Damage:	0			
Survey date:	30/10/2024 - 04/11/2024		Surface Treatment:	2			
Date last inspected:	14/11/2023 13:07:05		Asbestos Type:	1			
Next inspection due:	30th October 2025		Material Score:	5			
Building:	Morrison Nucleus Block Ground Floor		Priority Assessment	Occupant Activity:		1	
Floor level:	Ground Floor			Location:		2	
Room:	X-Ray 002 (XR002)			Accessibility:		0	
Position:	Electrics			Extent/amount:		0	Small amounts
Item Description:	Textile Gaskets			Number of Occupants:		1	
Level of Identification:	PRESUMED	Frequency of Use:		3			
Action:	Monitor and manage	Time in Area:		0			
		Maintenance activity:		0			
RISK CODE:	C	Frequency of Maintenance:		0			
		Priority Score:		4			
Comments:	95091/04	Total Score:	9	Material Status Change:			
				No Change

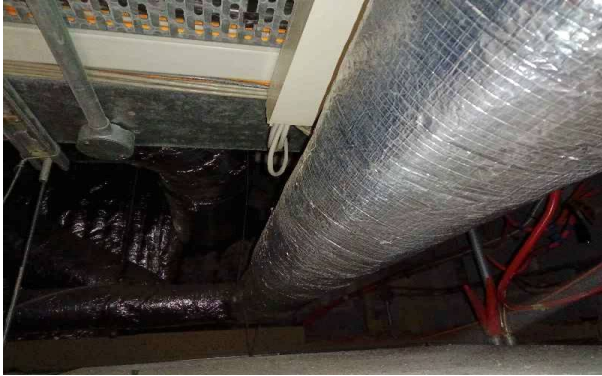
Item / Inspection Ref:	#69	Material Assessment	Product type:	2

Sample Ref:			Condition / Damage:	0		
Survey date:	30/10/2024 - 04/11/2024		Surface Treatment:	1		
Date last inspected:	14/11/2023 13:07:53		Asbestos Type:	1		
Next inspection due:	30th October 2025		Material Score:	4		
Building:	Morrison Nucleus Block Ground Floor	Priority Assessment	Occupant Activity:	1		
Floor level:	Ground Floor		Location:	2		
Room:	X-Ray 007 (XR007)		Accessibility:	0		
Position:	Ceiling Void		Extent/amount:	0		Small amounts
Item Description:	Textile Gaskets		Number of Occupants:	1		
Level of Identification:	PRESUMED		Frequency of Use:	3		
Action:	Monitor and manage		Time in Area:	0		
RISK CODE:	D	Maintenance activity:	0			
		Frequency of Maintenance:	0			
		Priority Score:	4			
Comments:	95091/07	Total Score:	8	Material Status Change: No Change

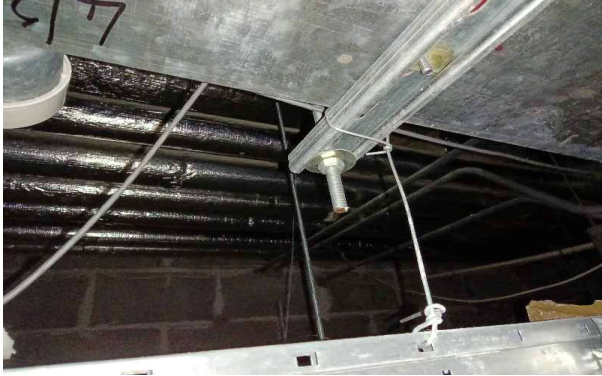
Item / Inspection Ref:	#70	Material Assessment	Product type:	2

Sample Ref:			Condition / Damage:	0		
Survey date:	30/10/2024 - 04/11/2024		Surface Treatment:	1		
Date last inspected:	14/11/2023 13:08:31		Asbestos Type:	1		
Next inspection due:	30th October 2025		Material Score:	4		
Building:	Morrison Nucleus Block Ground Floor	Priority Assessment	Occupant Activity:	1		
Floor level:	Ground Floor		Location:	2		
Room:	X-Ray 017 (XR017)		Accessibility:	0		
Position:	Ceiling Void		Extent/amount:	0		Small amounts
Item Description:	Textile Gaskets		Number of Occupants:	1		
Level of Identification:	PRESUMED		Frequency of Use:	3		
Action:	Monitor and manage		Time in Area:	0		
RISK CODE:	D	Maintenance activity:	0			
		Frequency of Maintenance:	0			
		Priority Score:	4			
Comments:	95091/08	Total Score:	8	Material Status Change: No Change

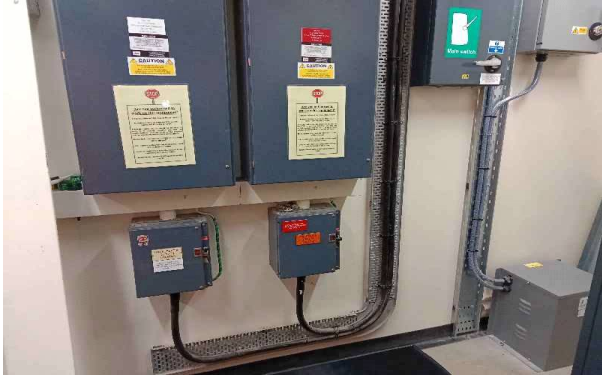
Item / Inspection Ref:	#71	Material Assessment	Product type:	2

Sample Ref:			Condition / Damage:	0		
Survey date:	30/10/2024 - 04/11/2024		Surface Treatment:	2		
Date last inspected:	14/11/2023 13:09:07		Asbestos Type:	1		
Next inspection due:	30th October 2025		Material Score:	5		
Building:	Morrison Nucleus Block Ground Floor	Priority Assessment	Occupant Activity:	1		
Floor level:	Ground Floor		Location:	2		
Room:	X-Ray 019 (XR019)		Accessibility:	0		
Position:	Electrics		Extent/amount:	0		Small amounts
Item Description:	Textile Gaskets		Number of Occupants:	1		
Level of Identification:	PRESUMED		Frequency of Use:	3		
Action:	Monitor and manage		Time in Area:	0		
RISK CODE:	C	Maintenance activity:	0			
		Frequency of Maintenance:	0			
		Priority Score:	4			
		Total Score:	9			
Comments:	95091/09				Material Status Change: No Change

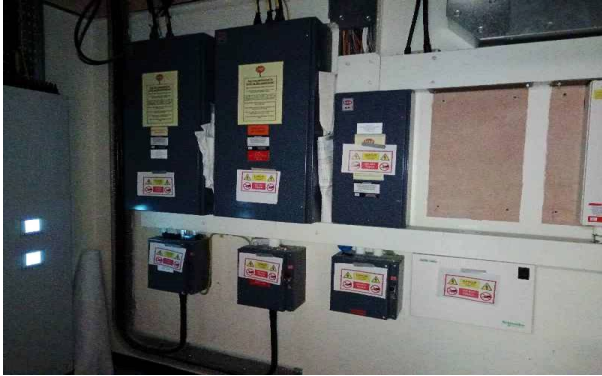
Item / Inspection Ref:	#72	Material Assessment	Product type:	2

Sample Ref:			Condition / Damage:	0		
Survey date:	30/10/2024 - 04/11/2024		Surface Treatment:	2		
Date last inspected:	14/11/2023 13:09:40		Asbestos Type:	1		
Next inspection due:	30th October 2025		Material Score:	5		
Building:	Morrison Nucleus Block Ground Floor	Priority Assessment	Occupant Activity:	1		
Floor level:	Ground Floor		Location:	2		
Room:	X-Ray 085 (XR085)		Accessibility:	0		
Position:	Electrics		Extent/amount:	0		Small amounts
Item Description:	Textile Gaskets		Number of Occupants:	1		
Level of Identification:	PRESUMED		Frequency of Use:	3		
Action:	Monitor and manage		Time in Area:	0		
RISK CODE:	C	Maintenance activity:	0			
		Frequency of Maintenance:	0			
		Priority Score:	4			
		Total Score:	9			
Comments:	95091/11				Material Status Change: No Change

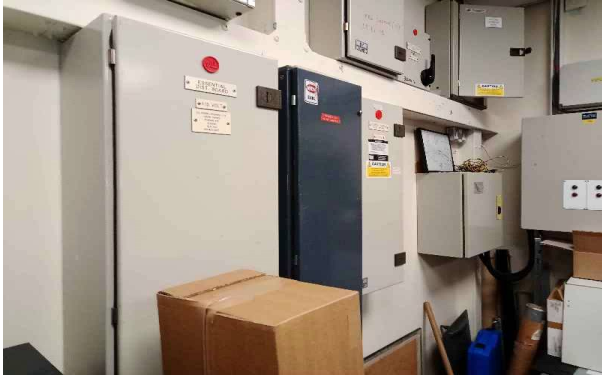
Item / Inspection Ref:	#73	Material Assessment	Product type:	2

Sample Ref:			Condition / Damage:	0			
Survey date:	30/10/2024 - 04/11/2024		Surface Treatment:	2			
Date last inspected:	14/11/2023 13:10:12		Asbestos Type:	1			
Next inspection due:	30th October 2025		Material Score:	5			
Building:	Morrison Nucleus Block Ground Floor		Priority Assessment	Occupant Activity:		1	
Floor level:	Ground Floor			Location:		2	
Room:	X-Ray 089 (XR089)			Accessibility:		0	
Position:	Electrics			Extent/amount:		0	Small amounts
Item Description:	Textile Gaskets			Number of Occupants:		1	
Level of Identification:	PRESUMED	Frequency of Use:		3			
Action:	Monitor and manage	Time in Area:		0			
		Maintenance activity:		0			
		Frequency of Maintenance:		0			
RISK CODE:	C	Priority Score:		4			
		Total Score:	9				
Comments:	95091/13				Material Status Change: No Change

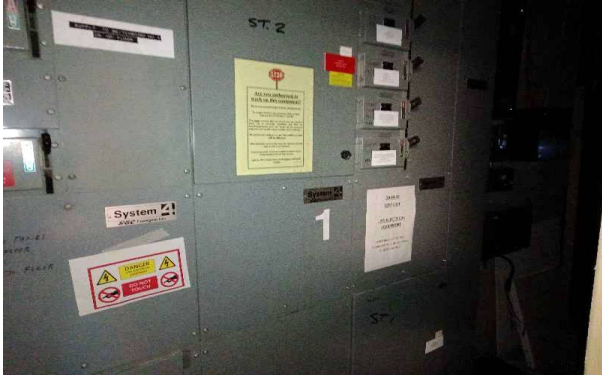
Item / Inspection Ref:	#74	Material Assessment	Product type:	2

Sample Ref:			Condition / Damage:	0			
Survey date:	30/10/2024 - 04/11/2024		Surface Treatment:	2			
Date last inspected:	14/11/2023 13:10:47		Asbestos Type:	1			
Next inspection due:	30th October 2025		Material Score:	5			
Building:	Morrison Nucleus Block Ground Floor		Priority Assessment	Occupant Activity:		1	
Floor level:	Ground Floor			Location:		2	
Room:	X-Ray 126 (XR126)			Accessibility:		0	
Position:	Electrics			Extent/amount:		0	Small amounts
Item Description:	Textile Gaskets			Number of Occupants:		1	
Level of Identification:	PRESUMED	Frequency of Use:		3			
Action:	Monitor and manage	Time in Area:		0			
		Maintenance activity:		0			
		Frequency of Maintenance:		0			
RISK CODE:	C	Priority Score:		4			
		Total Score:	9				
Comments:	95091/16				Material Status Change: No Change
